NIMBLE THIS PROACTIVE NETWORK MAINTENANCE AND COMSONICS SIGNAL LEAKAGE TOOLS

*A Valuable System for Isolating RF Impairments that Radically Aid Drop and
In-Home / Near Home Issue Resolution*

NIMBLE THIS LLC AND COMSONICS INC.

August 18, 2017

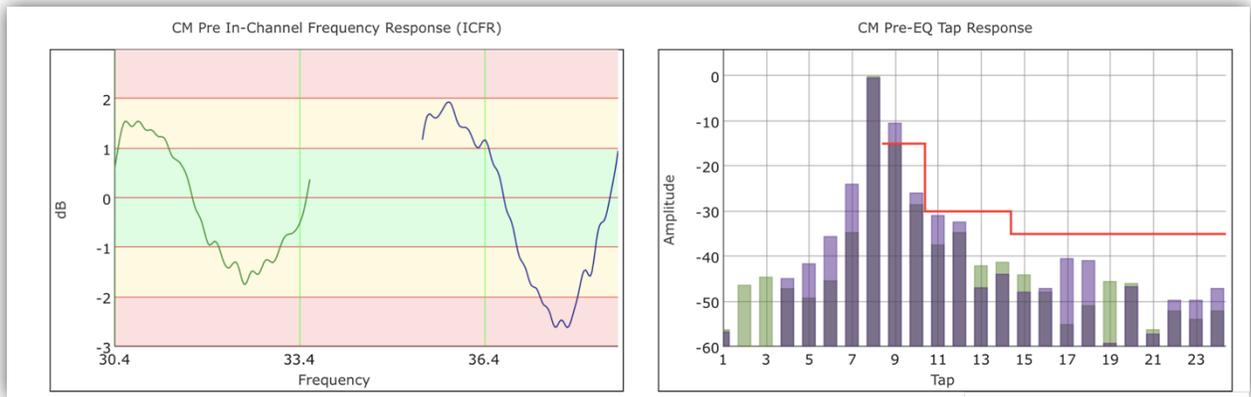
The first modem identified had significant in-channel frequency response (ICFR) and its pre-equalizer digital tap #9, shown in Figure 1, is elevated above the red threshold line.

Figure 1: Poor ICFR and Digital Tap #9 above red line (likely drop or in-home problem)

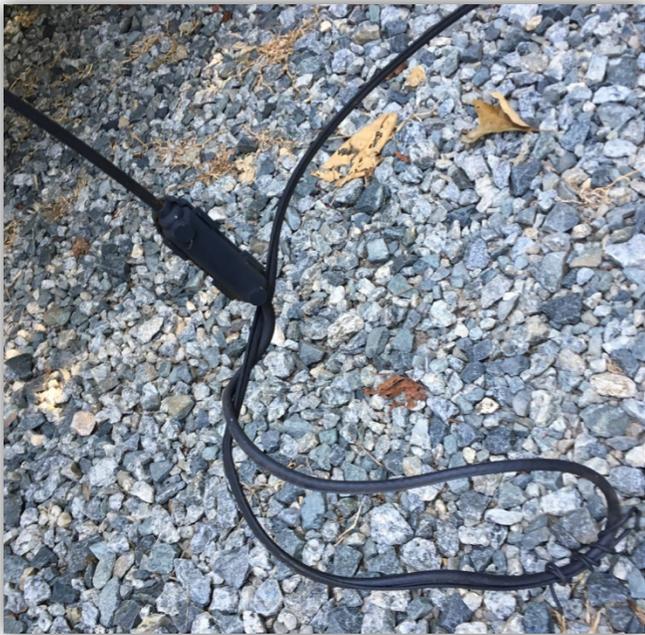
Once the M3 and QAM Compass were powered on, the technician immediately found a high level leak at the mainline tap while he was still in the bucket. There he found a splice had been

made just feet away from the tap. Figure 4 shows the splice enclosure and Figure 5 shows the connectors inside the splice enclosure, which includes two crimp-on F-connectors, one of which is severely corroded. Note that even though the connectors were in a waterproof splice enclosure, water still penetrated the enclosure and corroded the connectors. Do not count on your waterproof splice enclosure to protect your inline splices. **They will eventually fail.**

Figure 4: Inline Splice with Weather Enclosure

Best Practice #1: Avoid crimp-on F-connectors. Always use approved outdoor rated compression F-connectors to minimize future water ingress and corrosion, which will cause subscriber issues. It is recommended to avoid splices when possible. Further, Do not count on your waterproof splice enclosure to protect your inline splices. **They will eventually fail.**

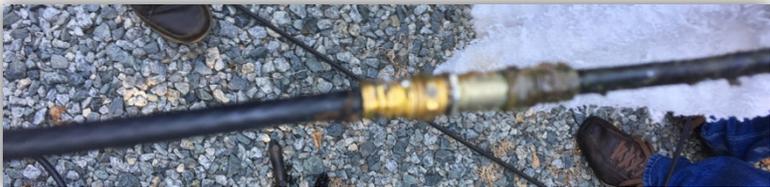
Figure 5: Crimp-on F-Connectors Exposed to Water and Corroded

The fix was to cut off both connectors and replace with a single weatherproof Snap-N-Seal compression connector. There was enough slack in the drop to connect it directly back to the drop without the inline splice. The resulting response is shown in Figure 6.

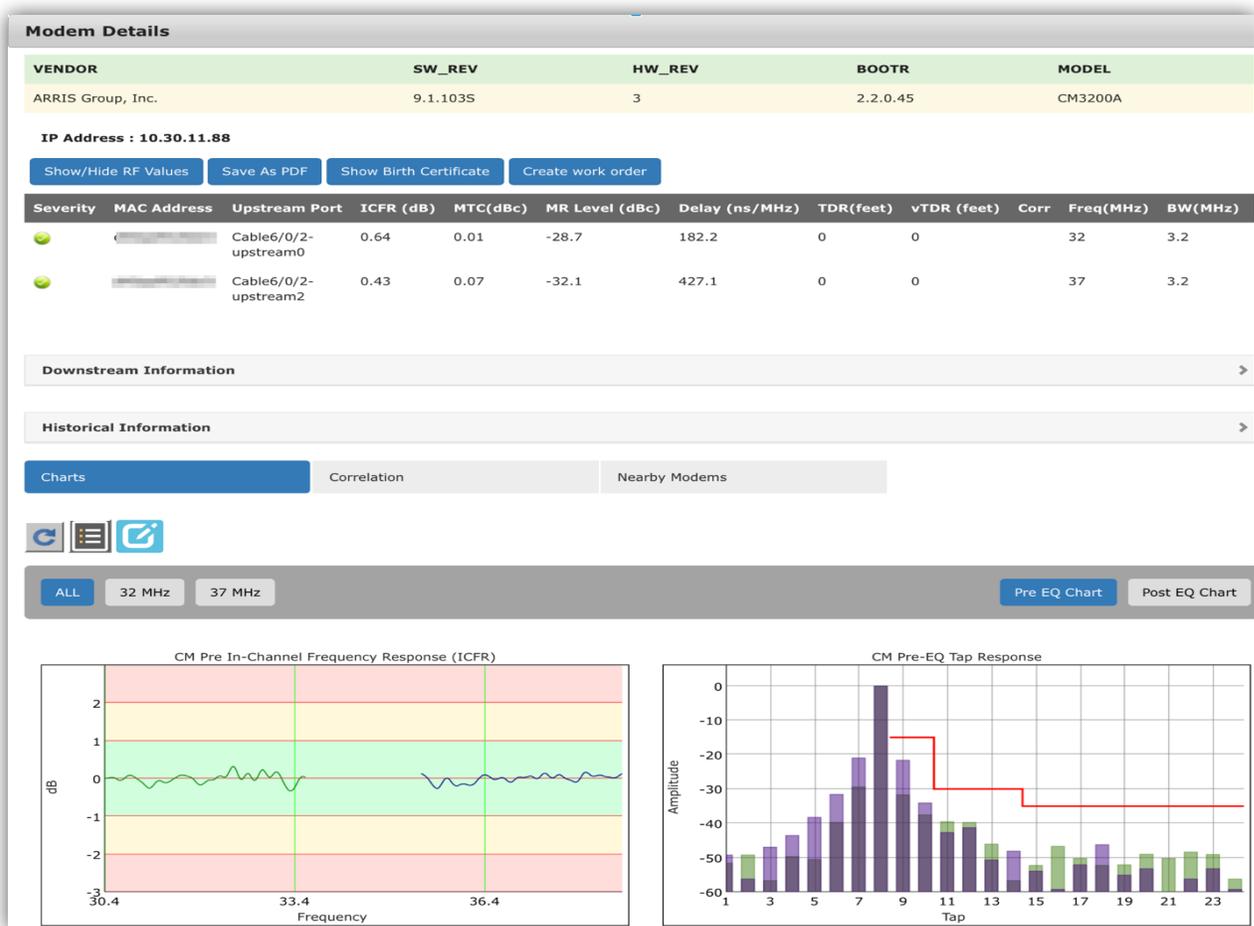
Figure 6: Subscriber 1 After Repair

Notice in Figure 6 that both upstream channels on subscriber 1's modem are now green. The MR Level (or micro-reflection level) are down to -28.7 dBc and -32.1 dBc for 32 MHz and 37 MHz, respectively. Previously these values were at -14.56 dBc and -11.83 dBc at 32 MHz and 37 MHz, respectively. An ideal micro-reflection level is any value less than -25 dBc, so this is a very good upstream after the repair.

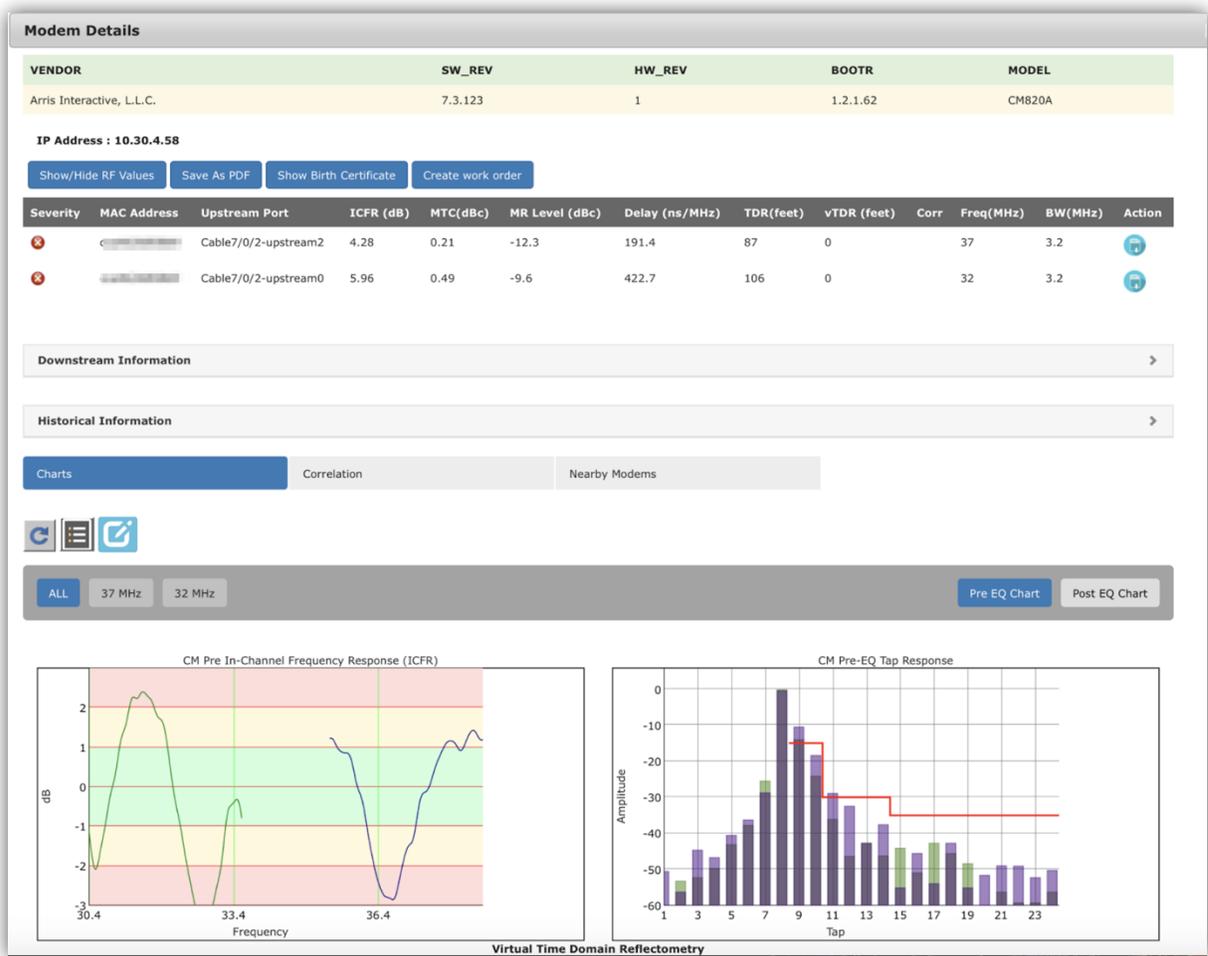
The second modem for analysis was identified with both upstream channels as having significant in-channel frequency response (ICFR) and micro-reflection levels. All surrounding modems in other homes were not impaired, so the confidence level was high that the impairment was either the drop or in-home related. Figure 7 shows the pre-equalizer response of the cable modem. Both digital pre-equalizer taps #9 and #10 are significantly elevated, which typically indicates a short echo cavity often associated with short span echoes common to drop cables.

Figure 7: Subscriber 2 Pre-Equalizer Data

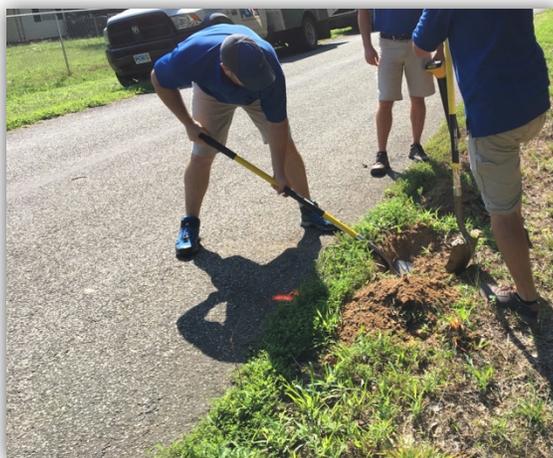
The technician walked in the direction of increasing RF signal leakage as shown on the ComSonics QAM Compass device. After several more minutes the highest level leak location was pinpointed near the road. The technicians started digging in the hopes of finding the coax cable as seen in Figure 9.

Figure 9: High Leak Location Being Excavated

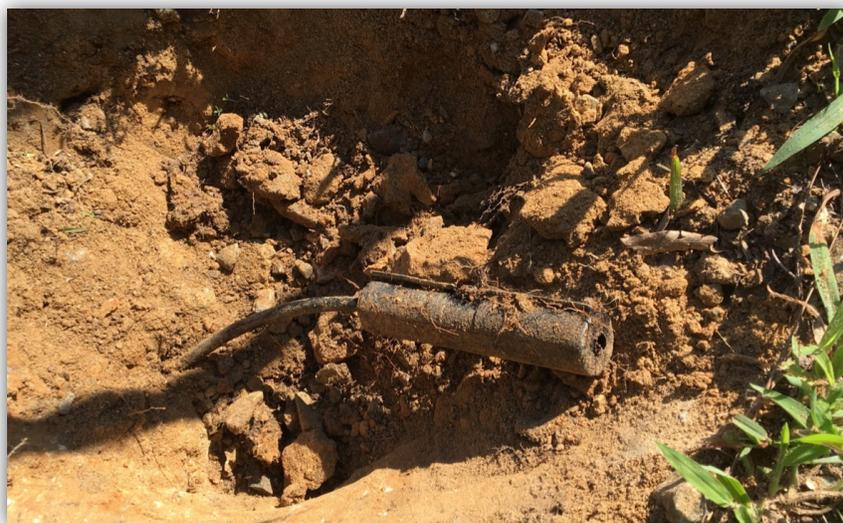
After 10 minutes of careful digging the coax cable was located along with a weatherproof splice enclosure. A technician pulled lightly on the splice enclosure when one end of the coax pulled loose from the splice enclosure indicating that the F-connector was not properly compression fitted to the cable. Figure 10 shows the splice enclosure with the missing cable.

Figure 10: Buried Splice Enclosure with Series 11 Cable Pulled from F-Connector

Best Practice #3: Avoid splices in buried drops. Not only are buried splices difficult to find, but unless they are in a very dry location, water ingress will almost always cause these to fail over time resulting in the splices to be replaced.

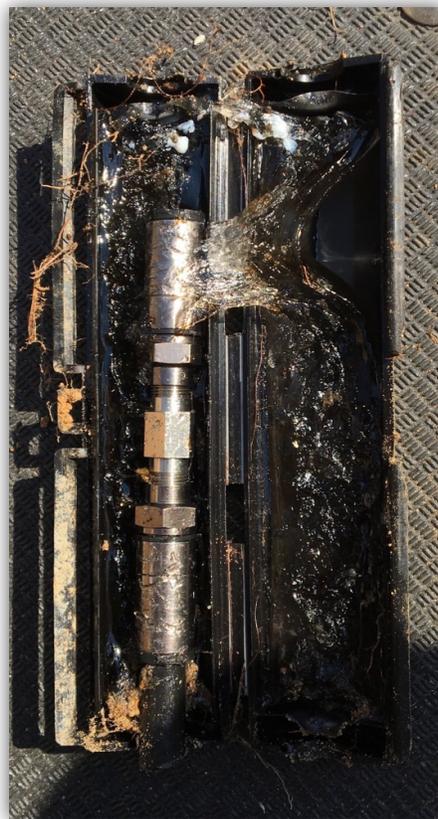
The splice enclosure was removed and opened. It was observed that quality F-Connectors were installed, however the installation of at least one of the F-Connectors allowed the coax cable to pull free. Additionally, there was the presence of water in the splice enclosure and some corrosion on the F-connectors as can be seen in Figure 11.

Figure 11: Opened Splice Enclosure with Water Ingress and Corrosion

A temporary drop was connected to the existing splice. A permanent drop will be installed in the future when the drop can be shot under the adjacent road without a splice. Once the temporary splice was in place all signal leakage stopped as measured by the ComSonics' QAM Compass. The modem was then rescanned using the Nimble This PNM mobile application. The modem performance improved significantly, however it still showed an RF impairment with an echo cavity of roughly 500 feet, which was approximately the length of the newly spliced drop combination. Since no other adjacent subscribers showed this same impairment it was deduced that the impairment was isolated to this subscriber's home. No additional leaks were detected from the drop or near the home. Consequently it was not necessary to go inside the home as leakage inside the home is normally detectable from outside of the home too. Therefore, we focused on all hardened devices on the drop.

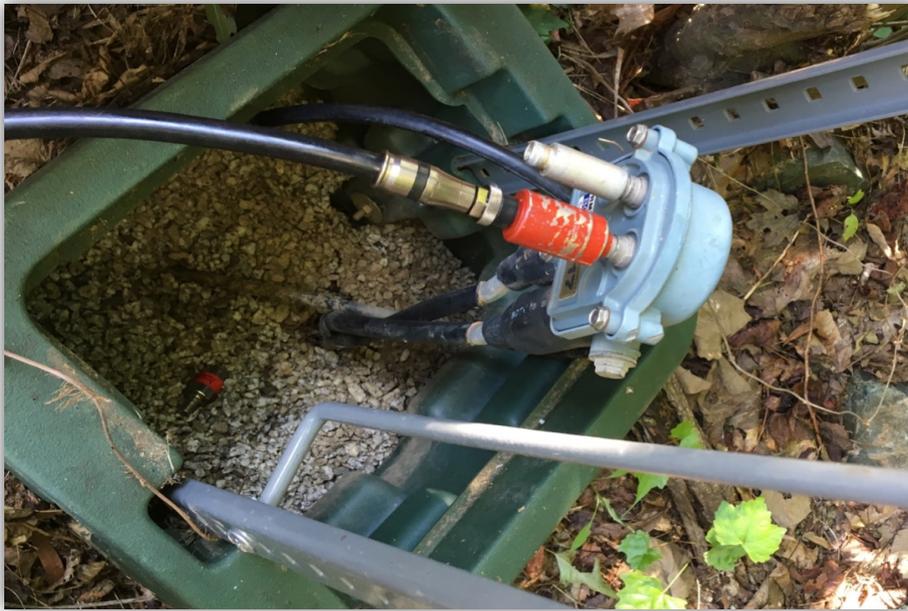
A data only trap was found at the mainline tap. This device is used to allow only the DOCSIS SC-QAM channels to pass, while it blocks all other video channels. It can be seen in Figure 12 as the red object connected to the tap.

Figure 12: Bad Drop Trap Causing Micro-Reflections

The red filter was removed and replaced with a new one. It is possible that the filter was damaged by lightning or failed with age. Upon rescanning the cable modem with the Nimble This PNM application the modem returned a near perfect upstream response as seen in Figure 13.

Best Practice #4: If you live in an area where lightning is prevalent be sure to check traps, filters and terminators for lightning damage. Most of these devices have small capacitors, resistors which will fail if lightning strikes nearby the drop or mainline coax cable, causing micro-reflections.

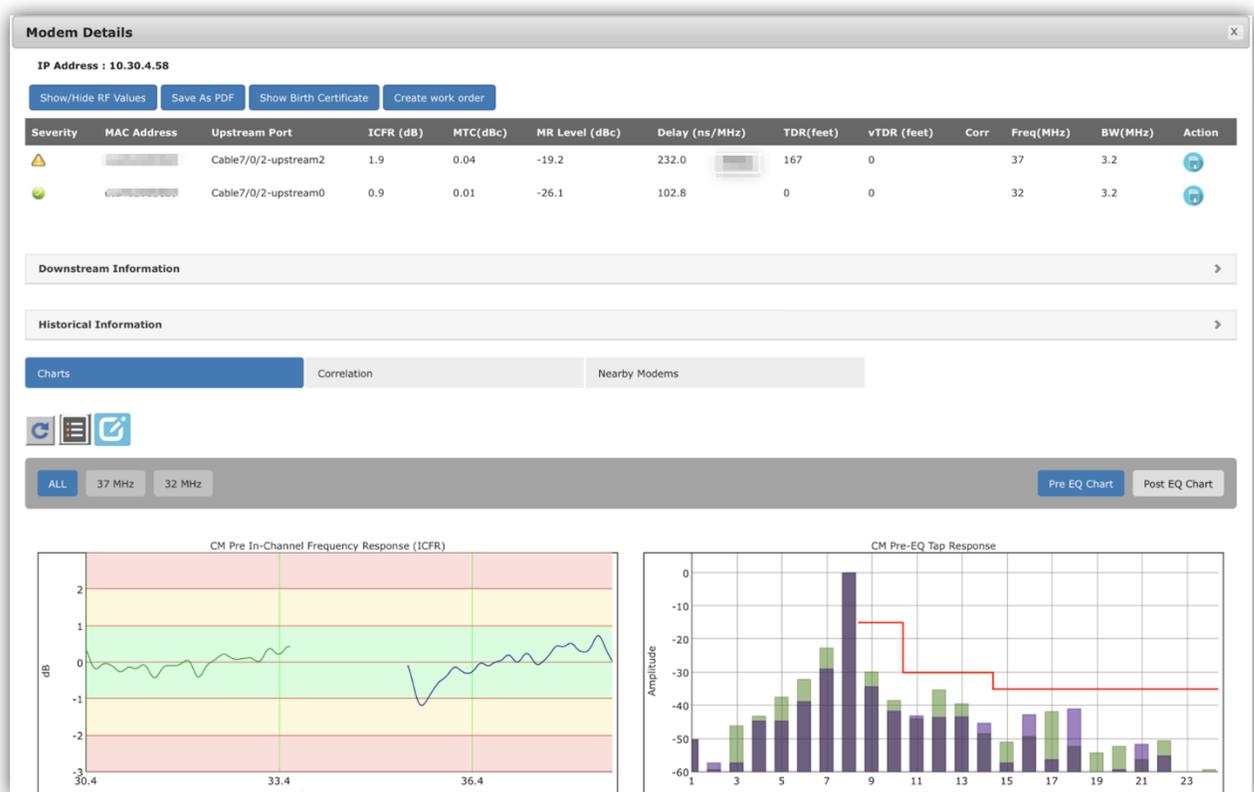
Figure 13: Subscriber 2 Modem After Splice and Trap Repair

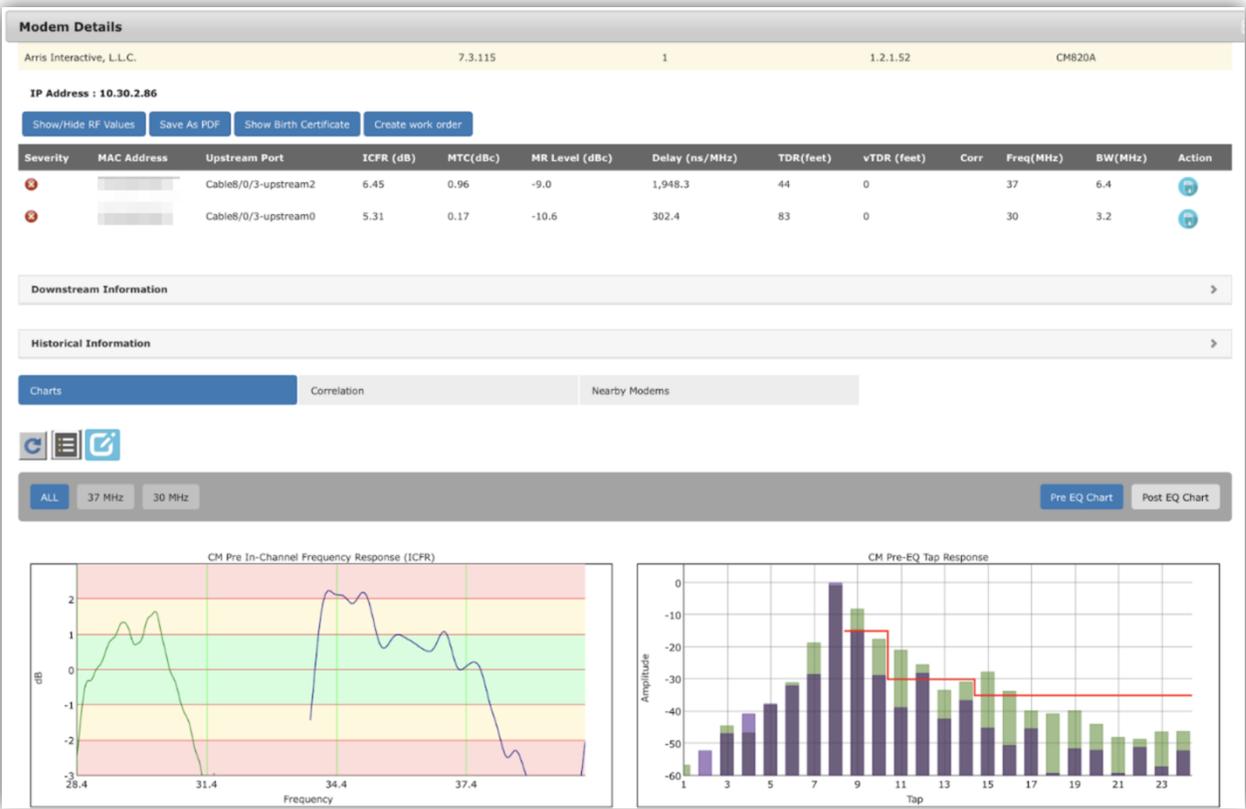
The next modem was again selected based on having poorly performing upstream channels, each with high micro-reflections and digital taps #9 and #10 elevated. Further, no other adjacent homes were experiencing similar characteristics. Figure 14 shows the modem’s response before the repair.

Figure 14: Subscriber 3 Modem Before Repair

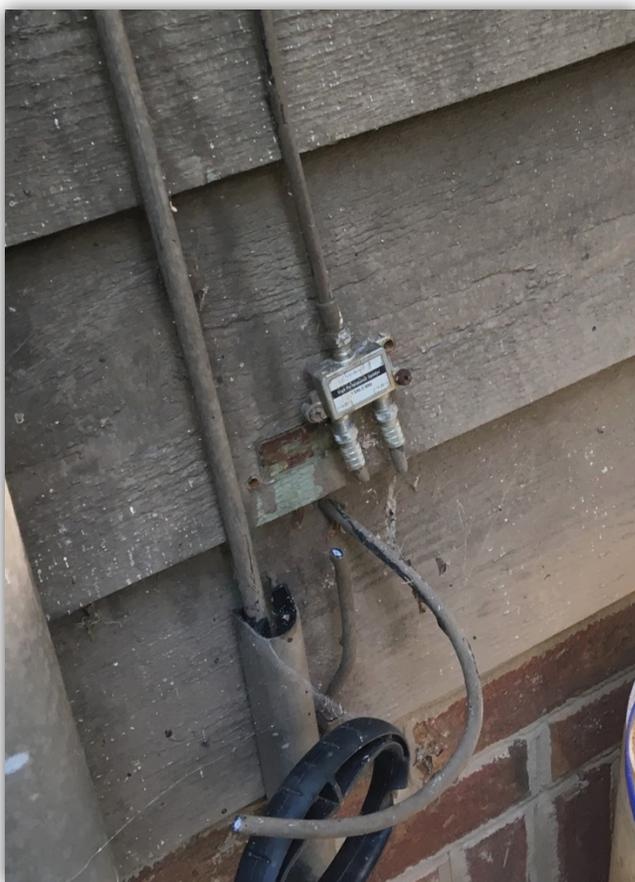
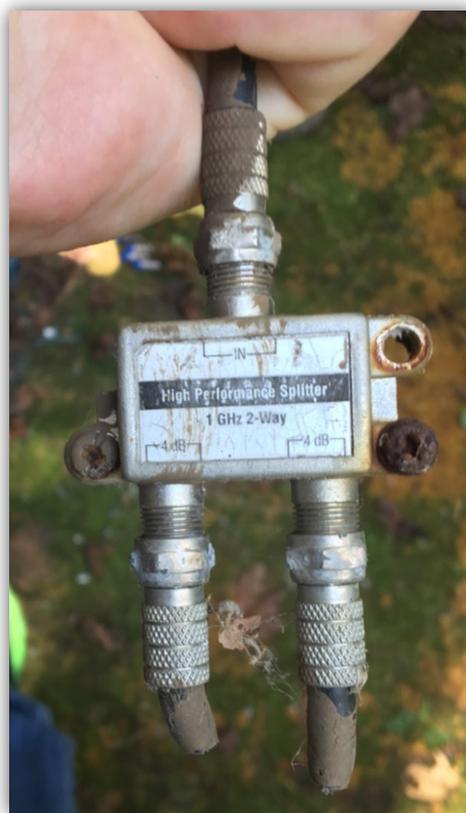
Upon connecting the ComSonics M3 to the subscriber drop substantial leakage was detected by the QAM Compass along the entire underground drop path. The technician followed the leakage to the side of the subscriber's home where a non-MSO splitter and push-on F-connectors were discovered as shown in Figure 15 (note the picture was taken just after the technician cut the cable at the output side of the splitter).

Figure 15: Old Splitter and Push-On F-Connectors

The splitter was removed and terminated at the single push-on F-connector feeding the splitter, but still substantial RF leakage was detected. This indicated the primary source of leakage was

the single push-on F-connector. All push-on F-connectors were replaced with weatherproof Snap-N-Seal compression F-Connectors and the splitter was replaced and relocated to the existing house box.

Best Practice #6: Locate all splitters in a weather protected house box or inside the subscriber's home or MDU (multi-dwelling unit). Unprotected splitters will rust and corrode causing premature failure and micro-reflections.

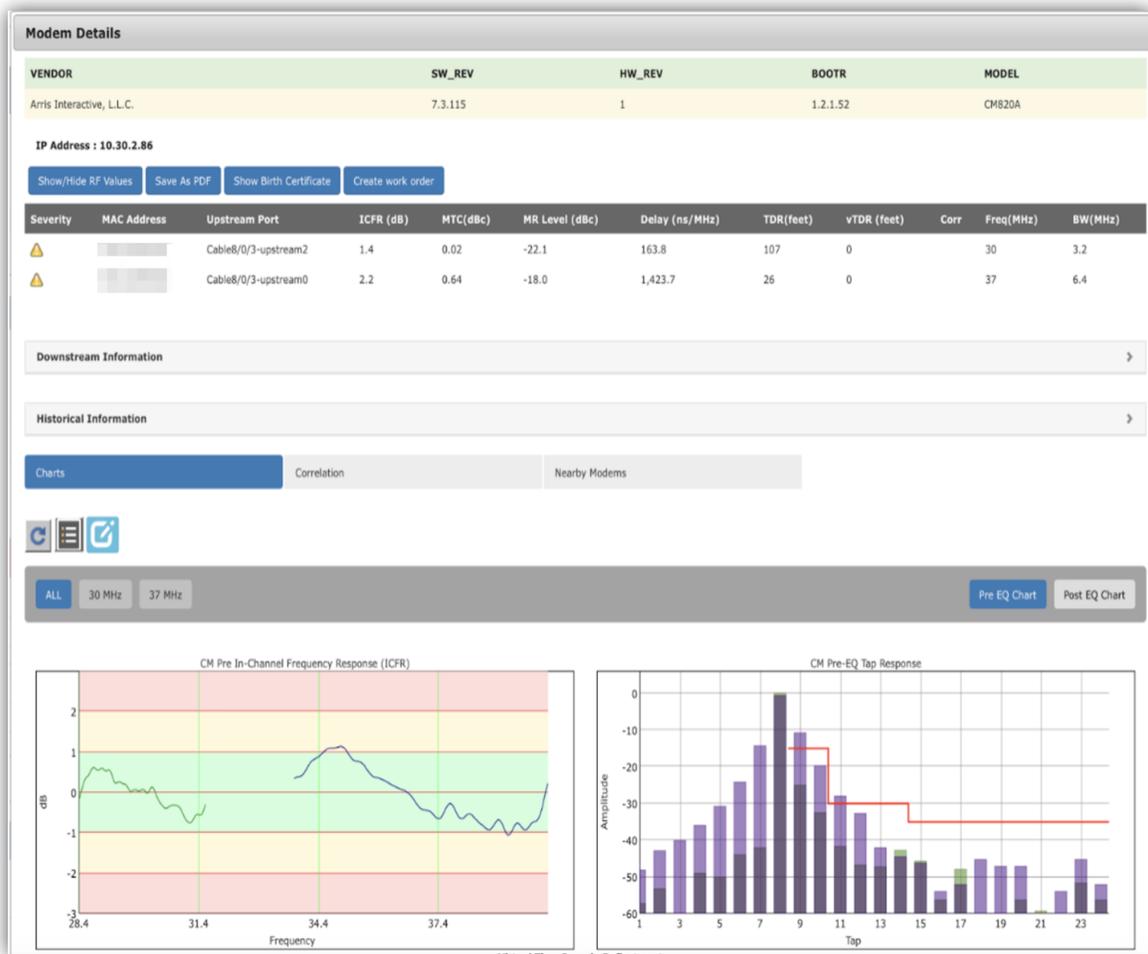
Upon completing the work, all RF leakage stopped and leaks were no longer detectable with the ComSonics' QAM Compass. The drop was reconnected and the Nimble This PNM mobile app was used to rescan the modem. The modem(s) performance was found to be significantly improved except for the group delay present on the upstream as seen on Subscriber #2's modem. This response can be seen in Figure 16.

Figure 16: Subscriber 3 Modem After Repair of Push-On F-Connectors

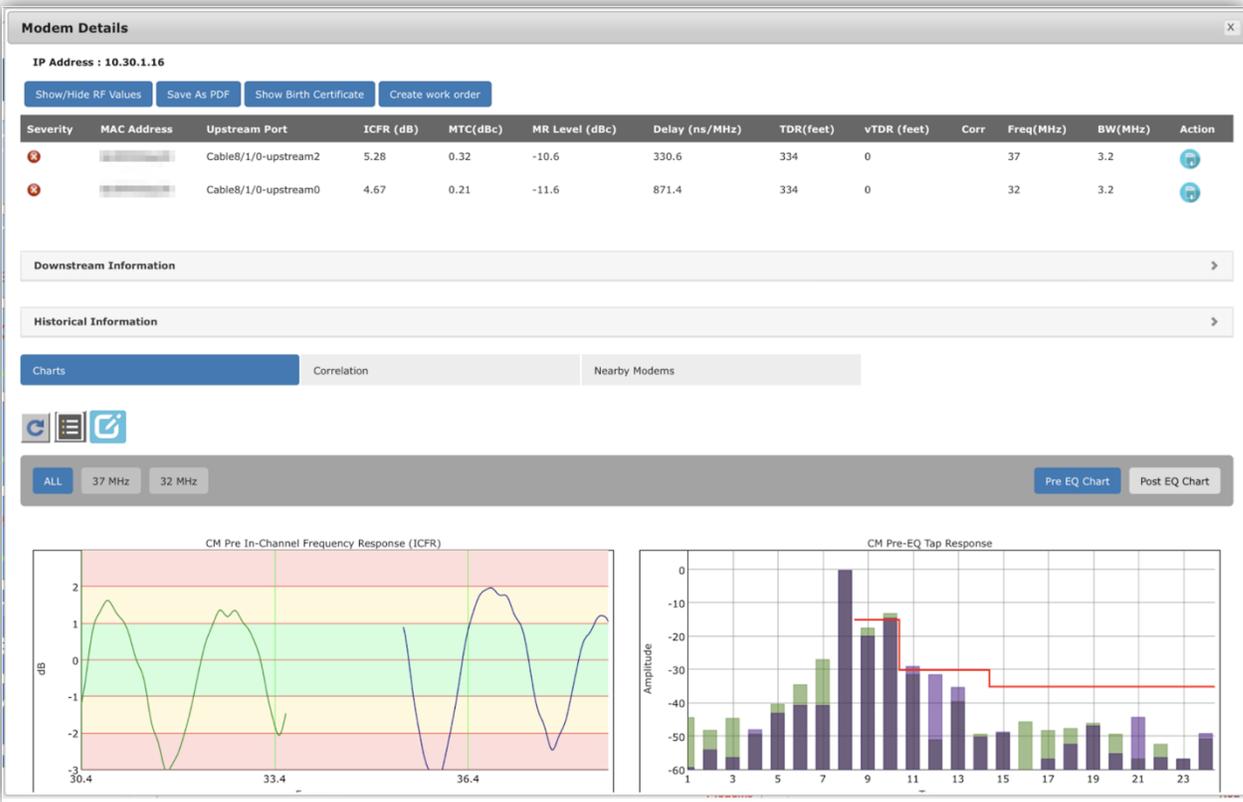
similar troubleshooting approach was used as in past subscribers, however it was apparent that the RF leakage was emanating from inside the subscriber’s home.

Figure 17: Subscriber 4 Modem Response Before Repair

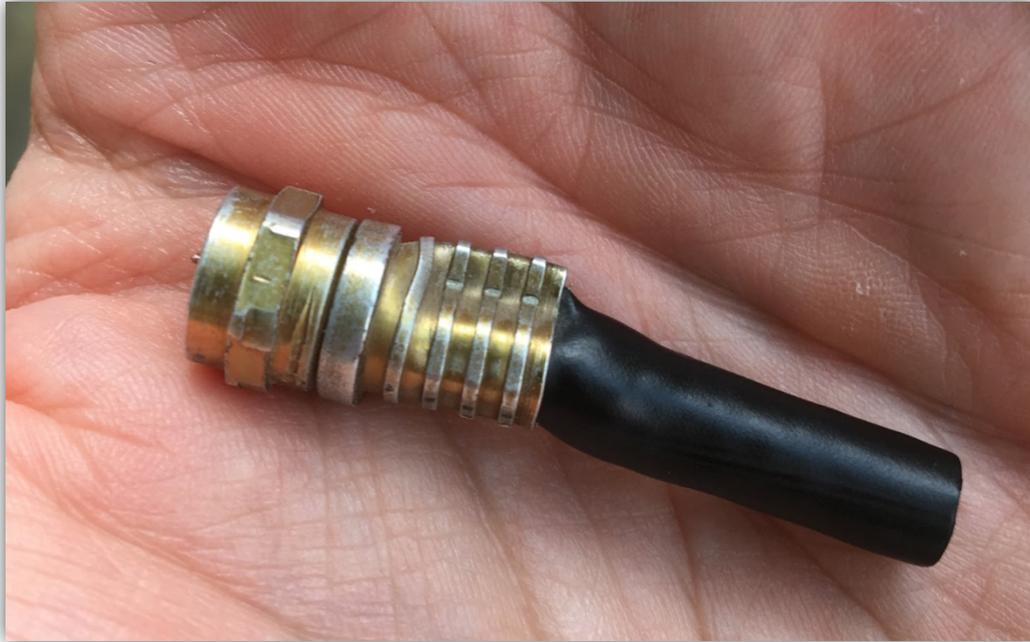
Upon entering the home the ComSonics’ QAM Compass quickly led the technician to the strongest source of the signal at the back of the cable modem. The technician found a crimp on F-Connector on the back of the cable modem. As soon as the connector was cut off the leak stopped immediately. The crimp-on-connector was replaced with a quality compression F-connector. Additional leakage was traced to a crawl space, but it was not significant and the technician indicated that he would return later to repair this minor leak.

Figure 18: Crimp-on F-connector On Back of Modem Causing Micro-Reflection

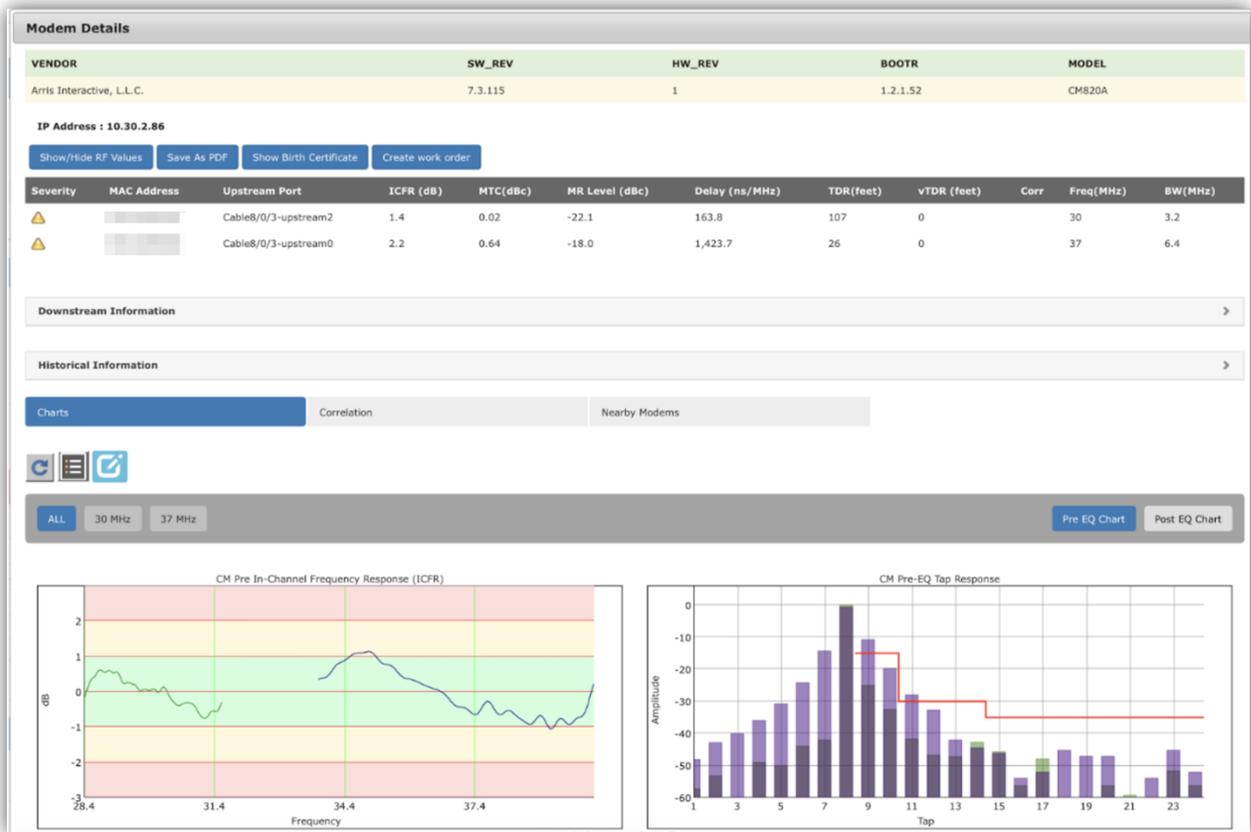
Upon rescanning the modem with the Nimble This PNM mobile app the modem pre-equalizer response confirmed that the majority of the impairment had been resolved turning the modem from red to yellow, however the leak in the crawl space was likely preventing the modem from turning to green. Figure 19 shows the modem's response after repairing the crimp-on F-connector on the back of the modem.

Figure 19: Subscriber 4 Modem After Repair of Crimp-on F-Connector

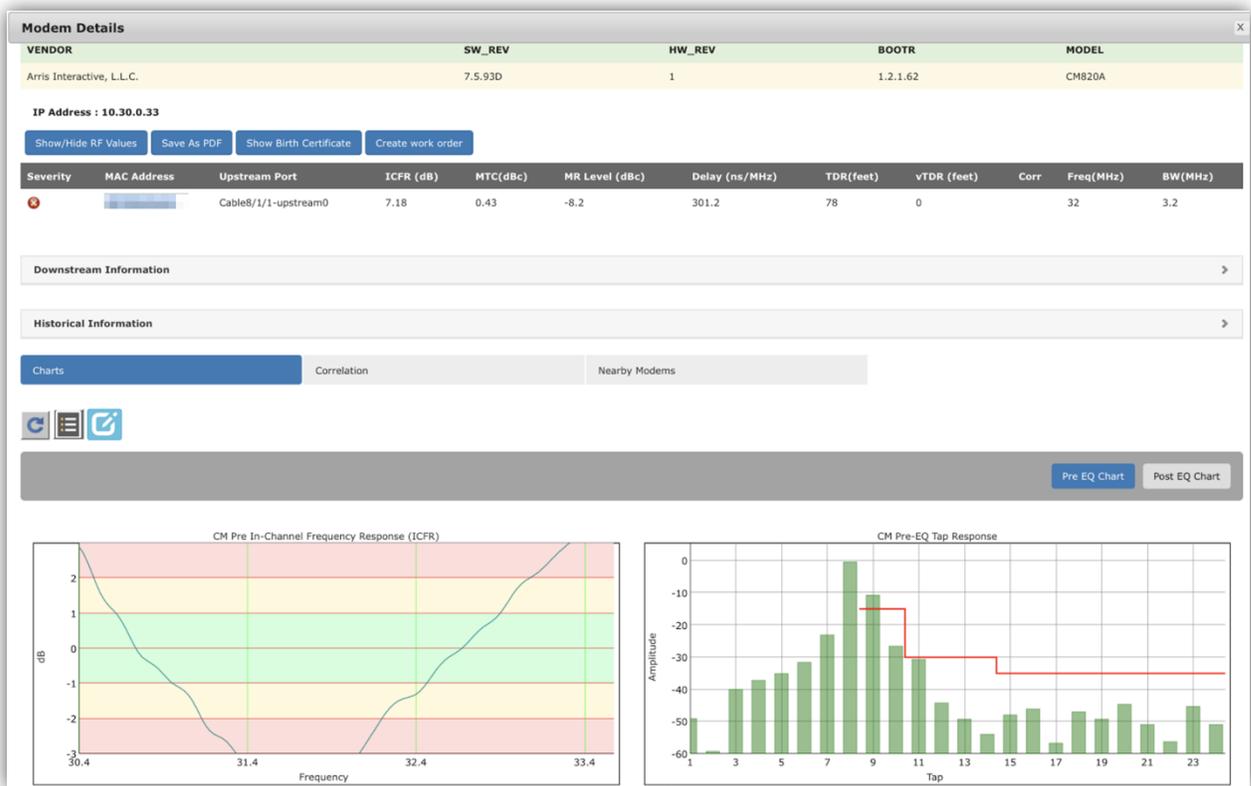
Figure 20 shows the modem's upstream response, with only one channel at 32 MHz and a micro-reflection level of -8.2 dBc. No adjacent subscribers are having this same issue and digital tap #9 is the highest elevation, indicating a likely drop, near home or in-home related impairment.

Figure 20: Subscriber 5 Before Repair

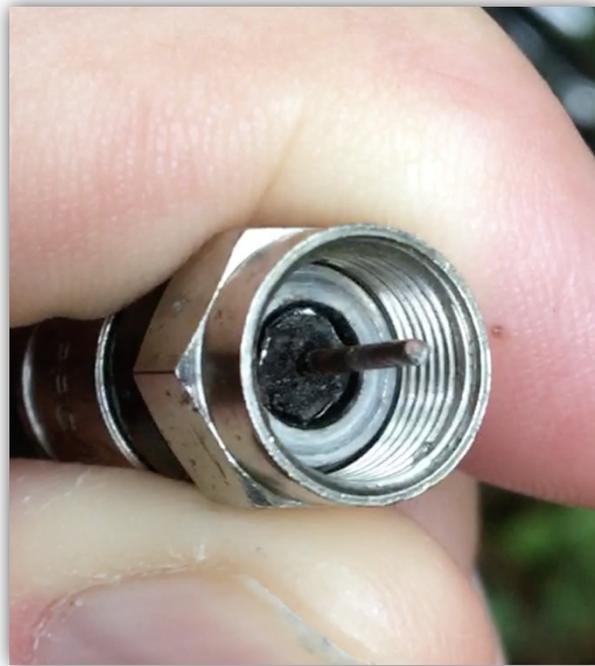
The technician removed the aerial drop and put it on the ground. It was inspected from one end to the other. While the drop showed no signs of physical damage from the outside, one F-connector showed possible signs of electrical surge as observed in Figure 21, where the insulating dielectric and center conductor were blackened. A significant electrical surge could have seriously damaged the drop at a bend location or perhaps along the entire drop cable causing RF leakage throughout.

Figure 21: Blackening of Center Conductor and Insulating Dielectric Indicating Possible Surge

Upon replacing the drop cable all signs of RF leakage disappeared. Further, upon reconnecting the drop and rescanning the modem using the Nimble This PNM mobile app it was found that not only had the original upstream channel turned from red to green, but the modem was no longer in partial mode. Now the modem was able to bond to both upstream channels and both upstream channels were green with minimal micro-reflections, as can be seen in figure 22.

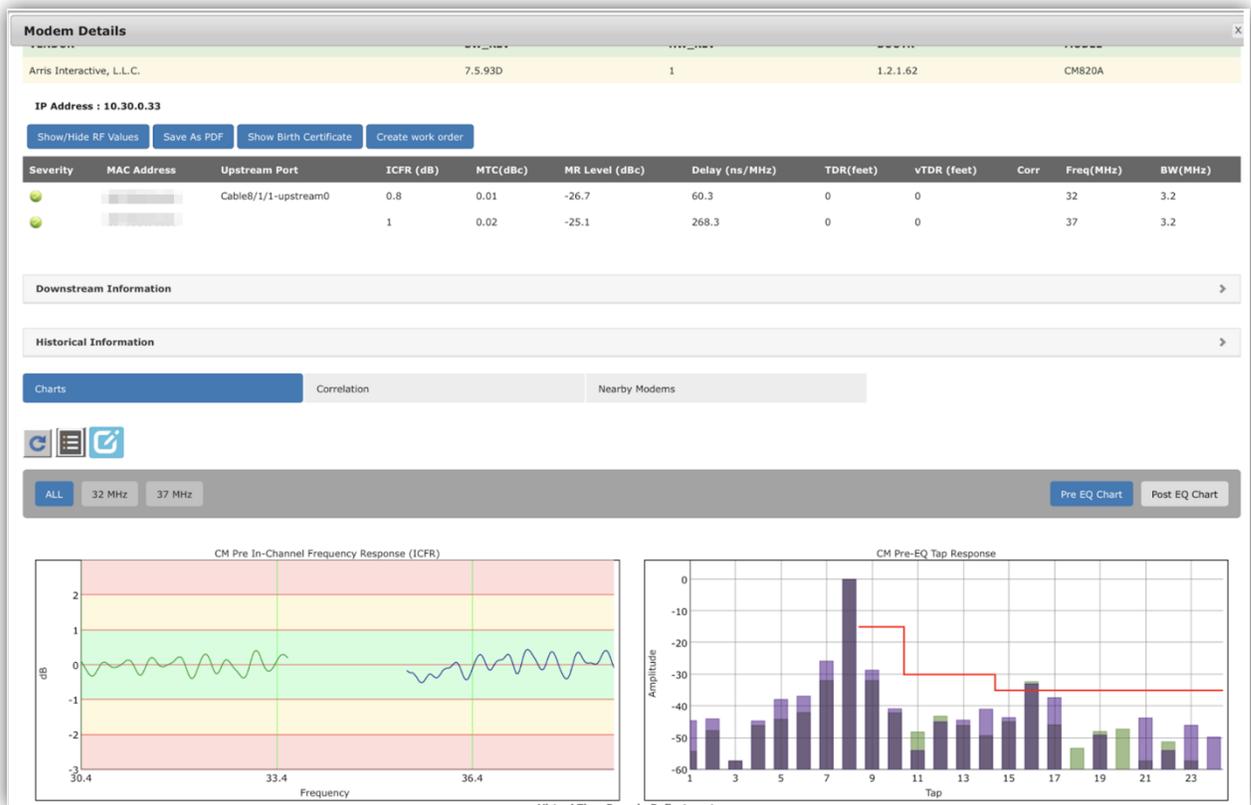
Figure 22: Subscriber 5 Modem After Replacing Bad Drop

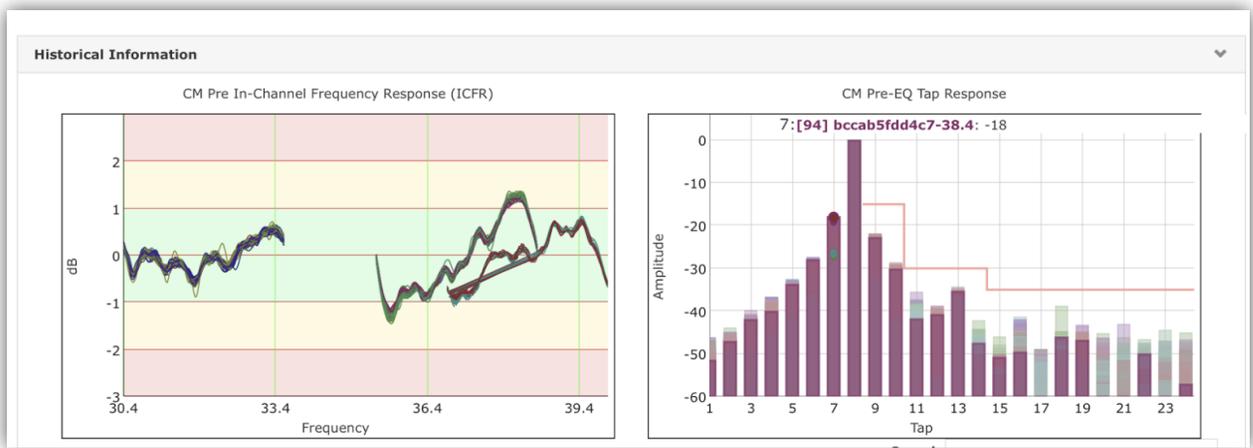
Figure 23: Subscriber 6 Modem Before Repair

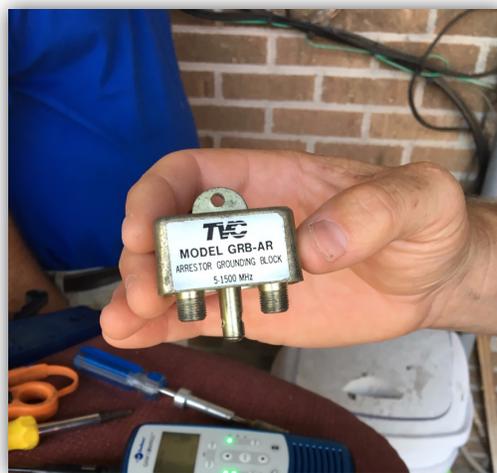
Impairment Found: Intermittent issue due to faulty TVC Arrestor Ground Block. The faulty ground block shown in Figure 24 was only detected because it was leaking significant amounts of ComSonic’s M3 RF energy. Faulty ground blocks are not common, but it is assumed this “surge arresting” type ground block had been damaged by a surge.

Figure 24: Faulty Surge Arresting Ground Block

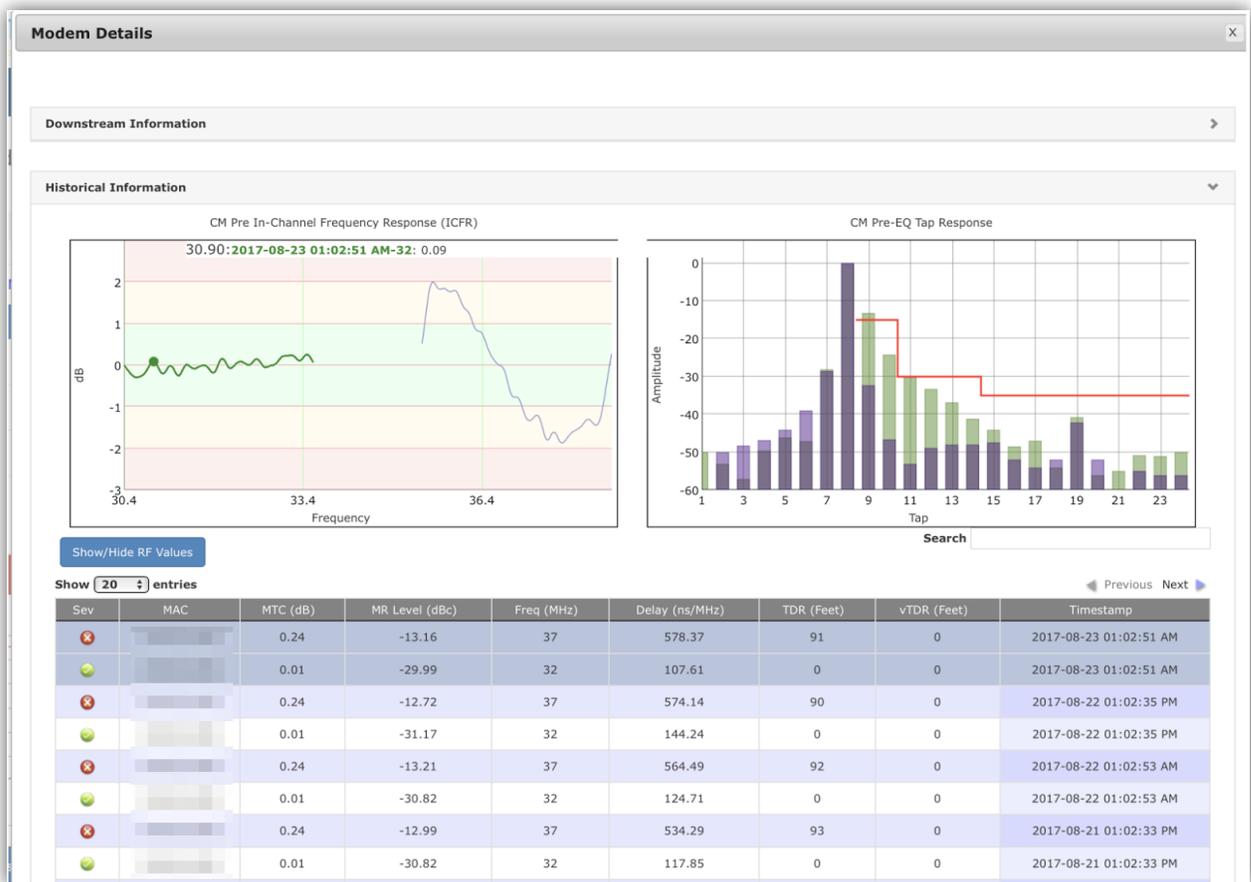
Figure 26: Subscriber 7 Modem Before Repair

Impairment Found: Multiple leaks found inside the house due to crimp-on style F-connectors and an unnecessary house-amp in front of the modem. Upon replacing all older style connectors with quality connectors, no leaks were observed and the modem response in Figure 27 resulted.

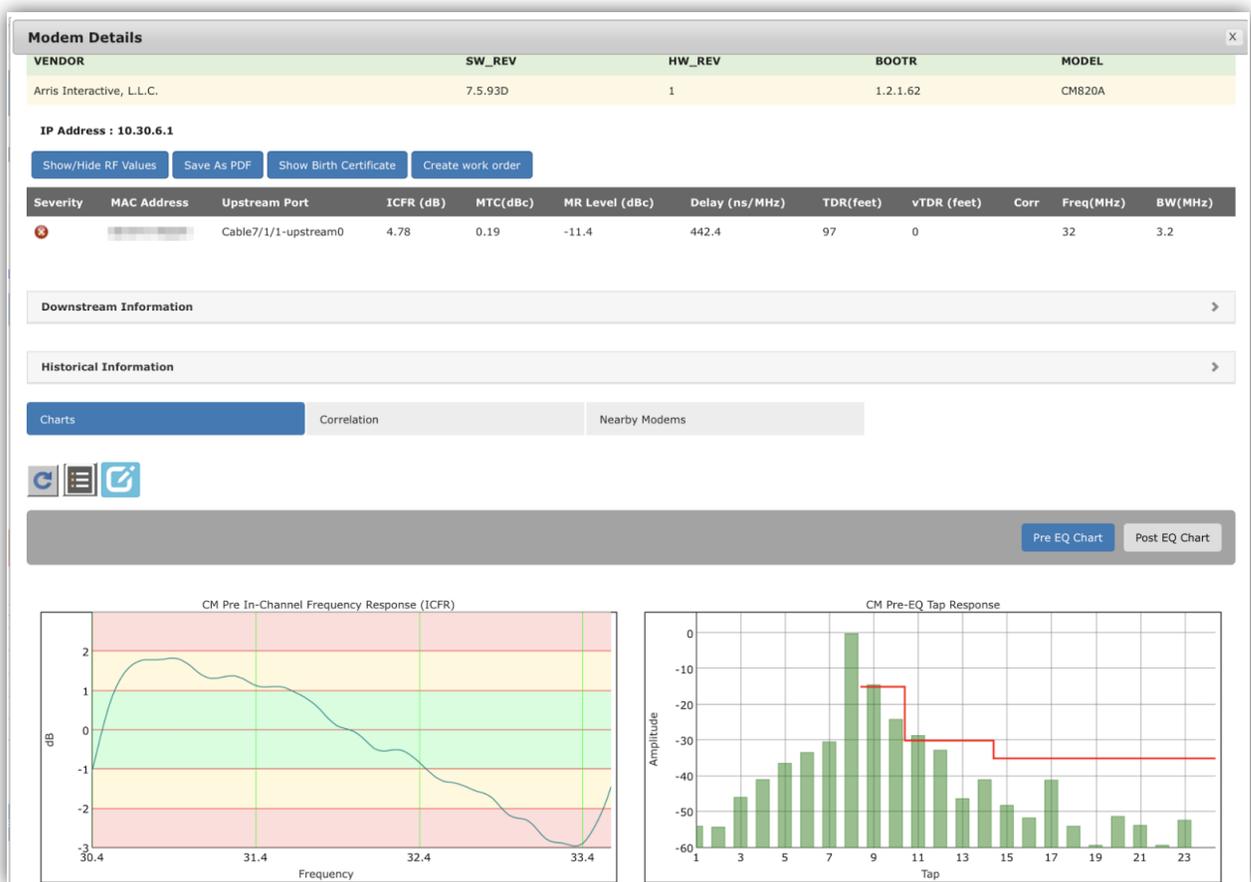
Figure 28: Subscriber 8 Modem Before Repair

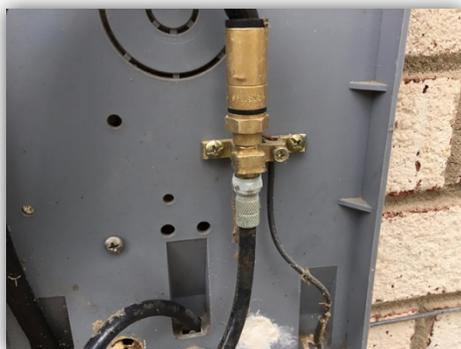
Impairment Found: RF leakage was found at a twist on connector at the ground block and push on connectors and splitter at the back of the subscriber’s TV on a common splitter with the modem. Visible braid was wrapped around the center conductor of the connector. In addition the connector at the tap was blackened due to electrical or water damage (hard to tell), and multiple bad connectors and jumpers inside of home. All impairments were detected by ComSonics’ M3 leakage indicated on the QAM Compass. Repair success was verified using the combination of Nimble This PNM and ComSonics M3.

Figure 29: Twist on F-Connector at Ground Block

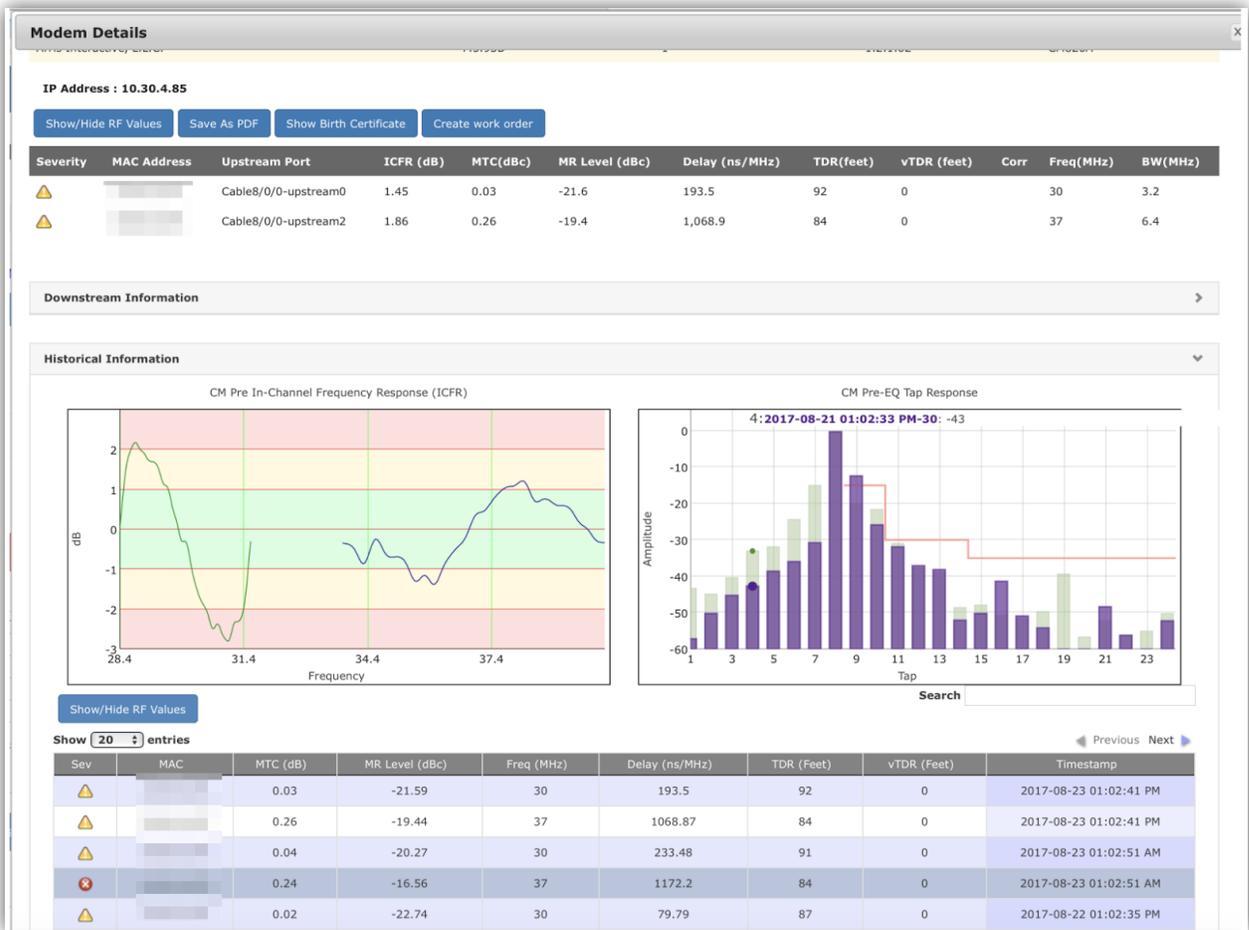
Figure 31: Subscriber 9 Modem Before Repair

Impairment Found: Bad connector at pole ground block and possible bad trap at tap

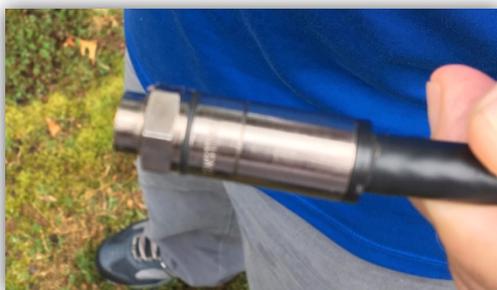
Figure 32: Bad Compression Type F-Connector
