NIMBLE THIS PROACTIVE NETWORK MAINTENANCE AND COMSONICS SIGNAL LEAKAGE TOOLS

*A Valuable System for Isolating RF Impairments that Radically Aid Drop and
In-Home / Near Home Issue Resolution*

NIMBLE THIS LLC AND COMSONICS INC.

August 18, 2017

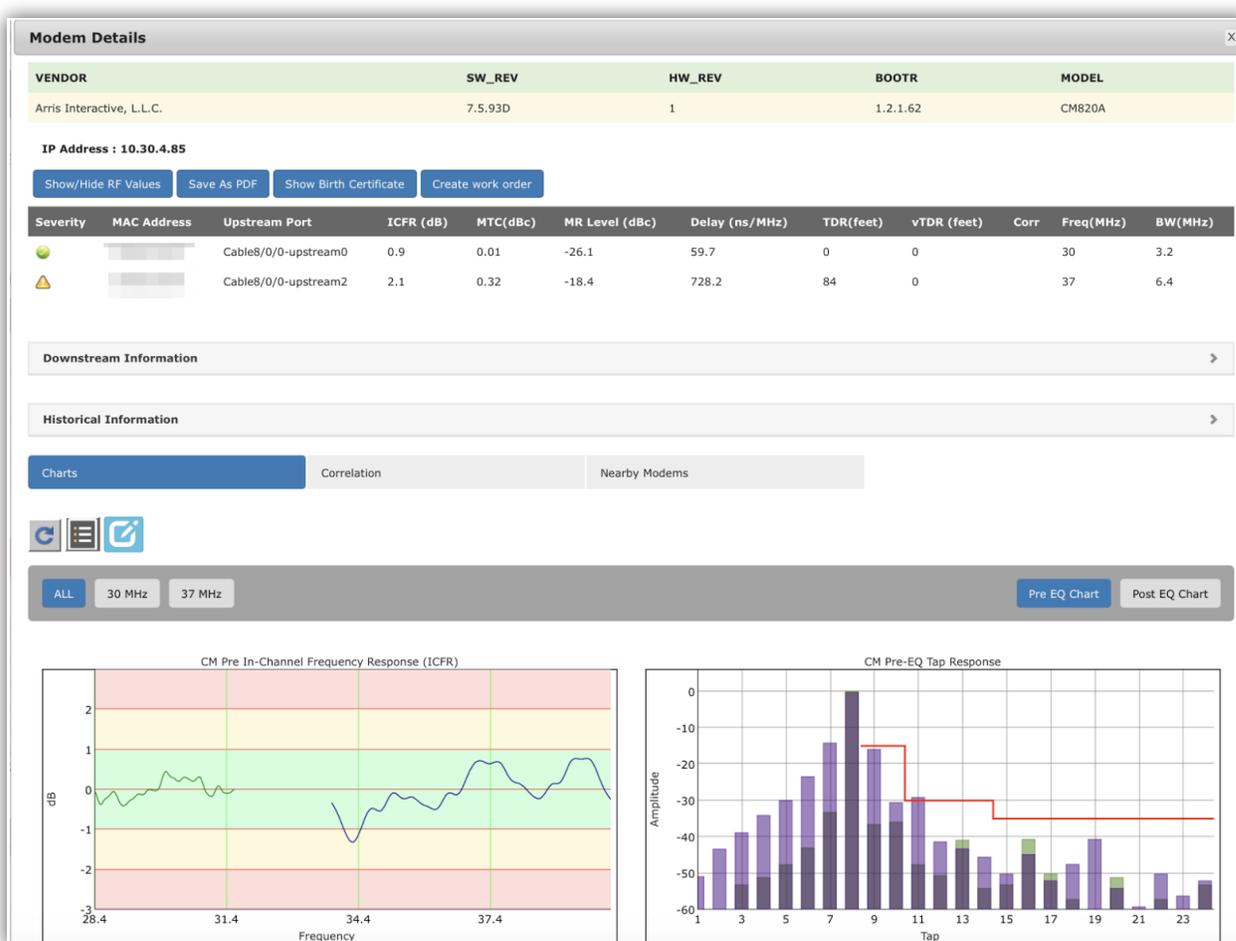
Figure 33: Subscriber 9 Modem After Replacing Bad F-Connector - Note there is still an impairment associated with the outside plant on the upstream near the band edge at 37 MHz

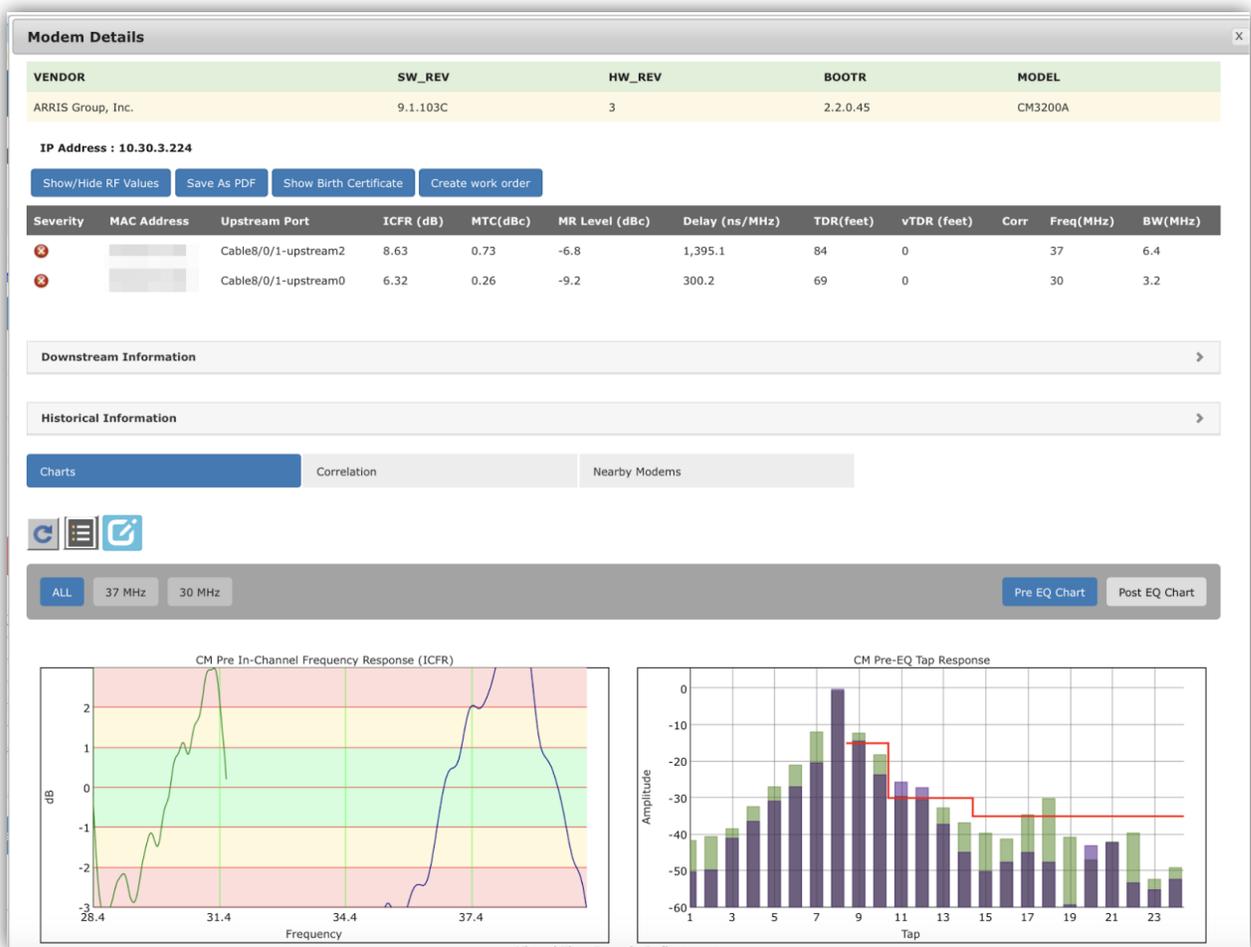
Figure 34: Subscriber 10 Modem Before Repair

Impairment Found: Cable from ground block was connected to an unused Dish TV splitter sitting in a small pond of water hidden in a crawl space under the subscriber dwelling. The splitter was fortunately leaking large ComSonics' M3 test signal amounts, which the QAM Compass made finding it easy. The Dish TV splitter was removed and a direct run was installed to the modem.

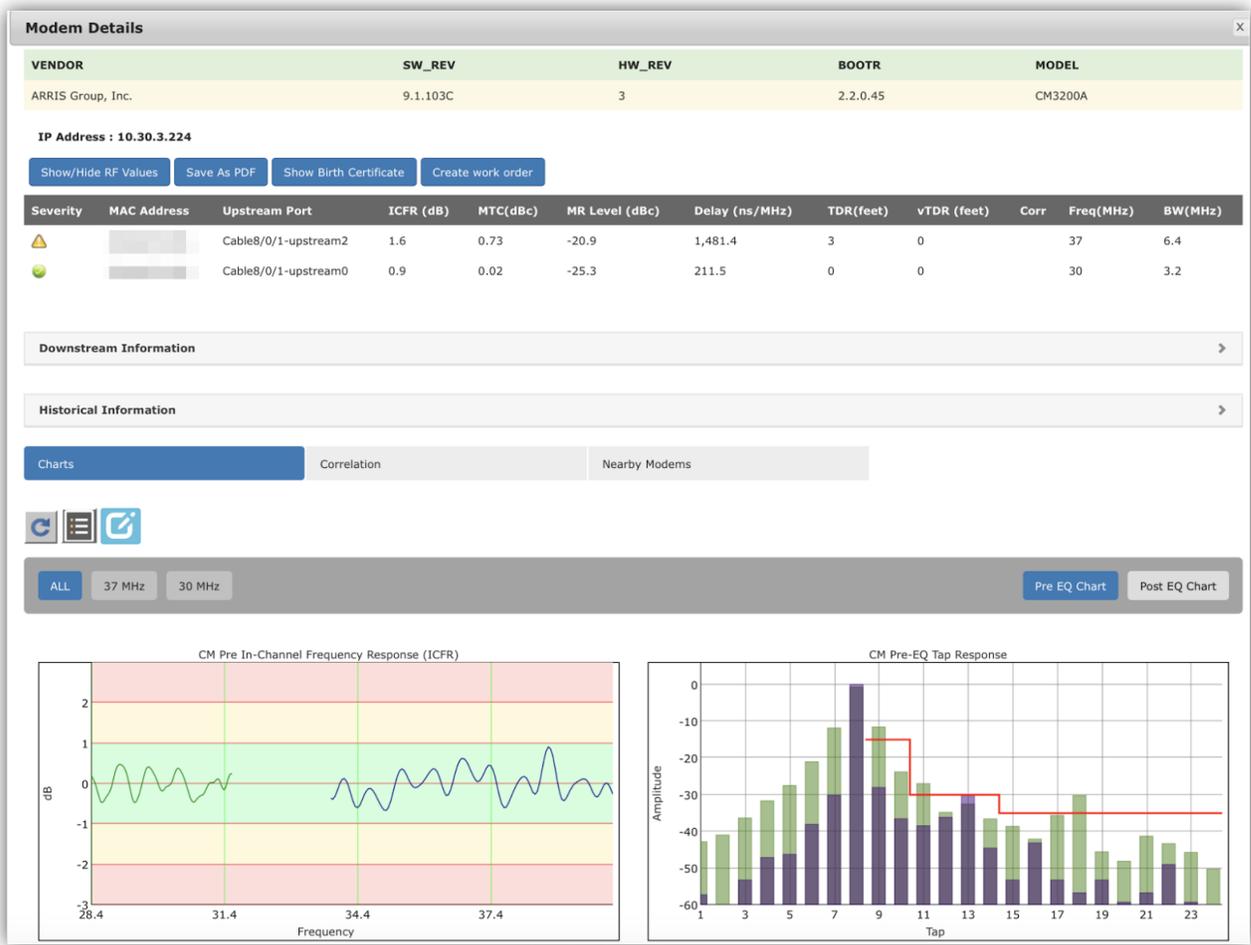
Figure 35: Subscriber 10 Modem After Removing Dish TV Splitter (Impairment at upper channel due to outside plant)

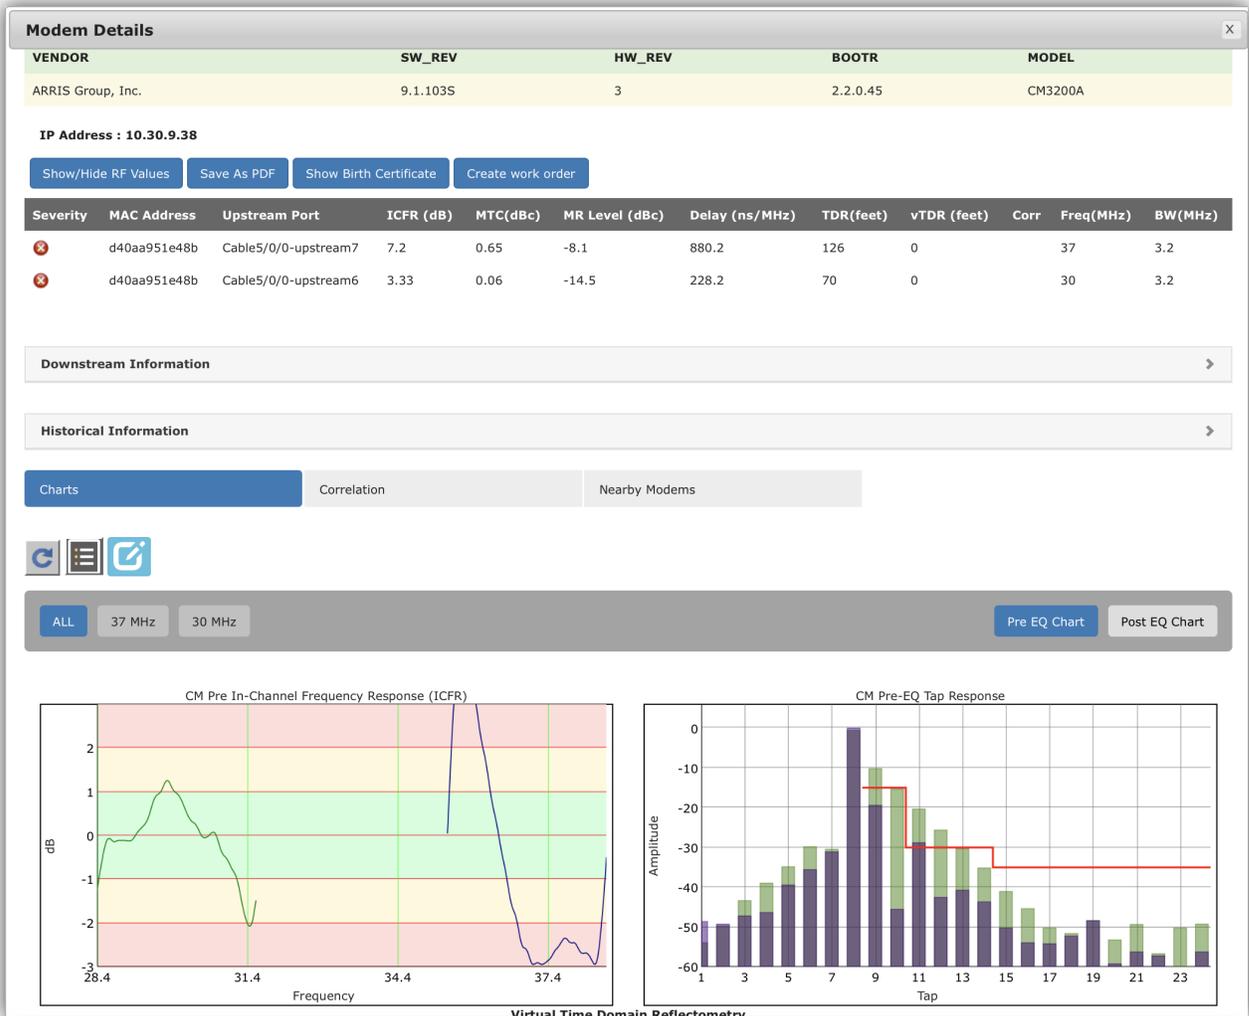
Figure 36: Subscriber 11 Modem before replacing drop

Subscriber 11: Replaced the drop which was damaged or had an existing bad splice (tracked with M3/Compass). Found a unterminated cable outlet inside the house with a very large leakage. The rest of the inside was quiet. After repairs, the downstream improved significantly, but there was still an issue with the modem. The problem was most likely due to a problem on the network side.

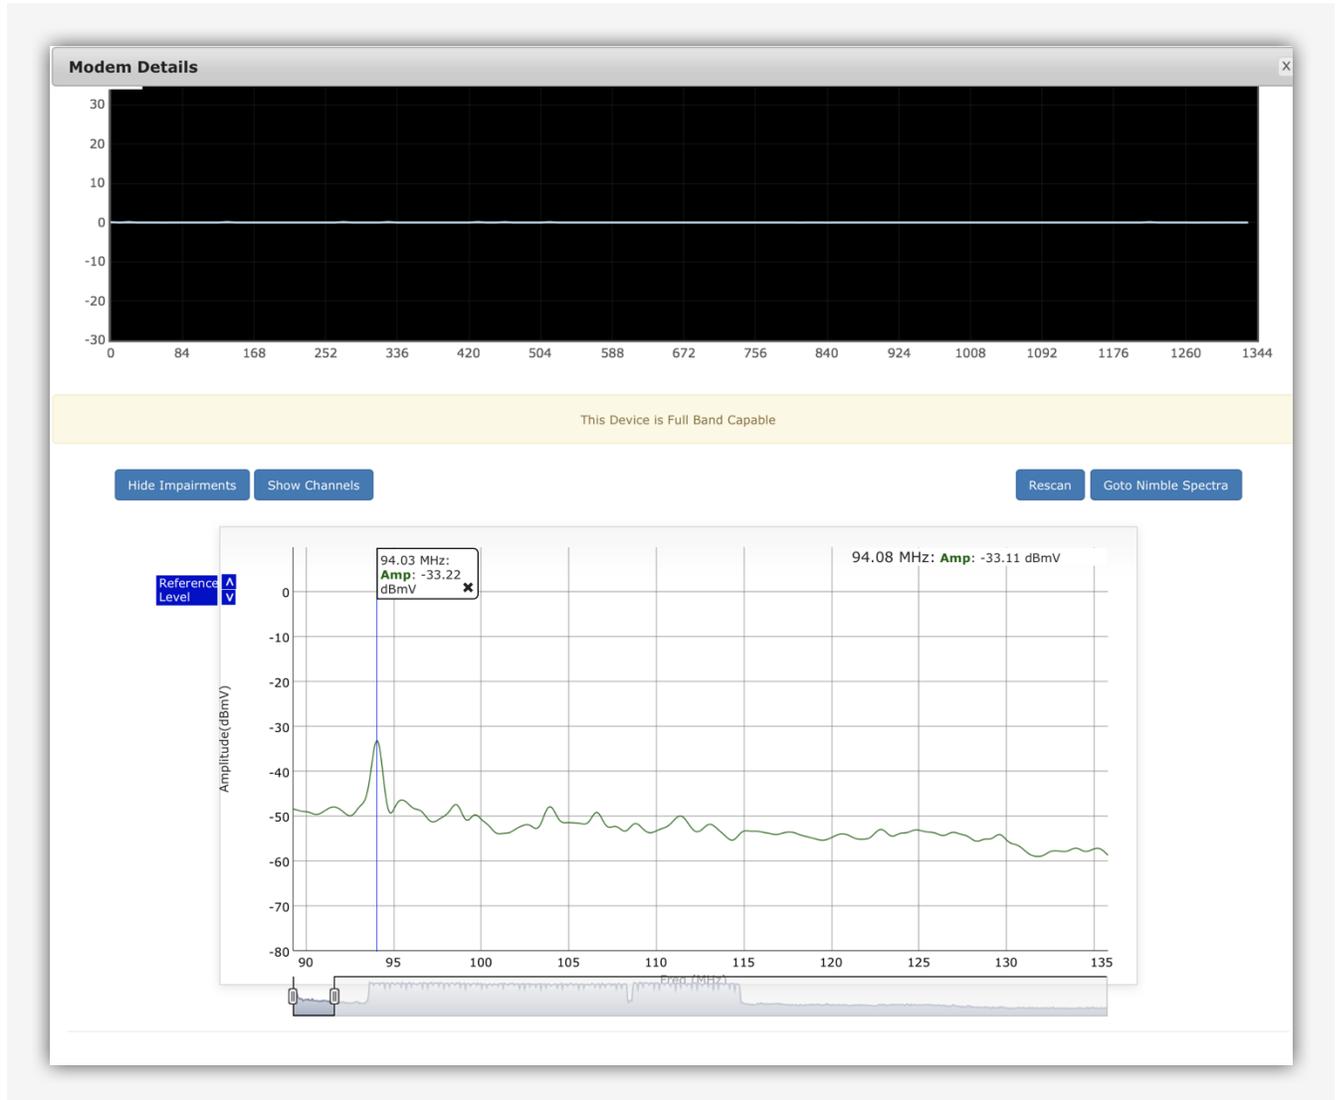
Figure 38: Subscriber 12 Modem Before replacing Connectors

As shown in Figure 38, this subscriber was experiencing FM ingress in the downstream at a frequency of 94.03 MHz. This is an expanded view of the full spectrum capture from the modem. The problem was found to be a series of problems including a bad drop, bad splitter, and crimp-on connectors.

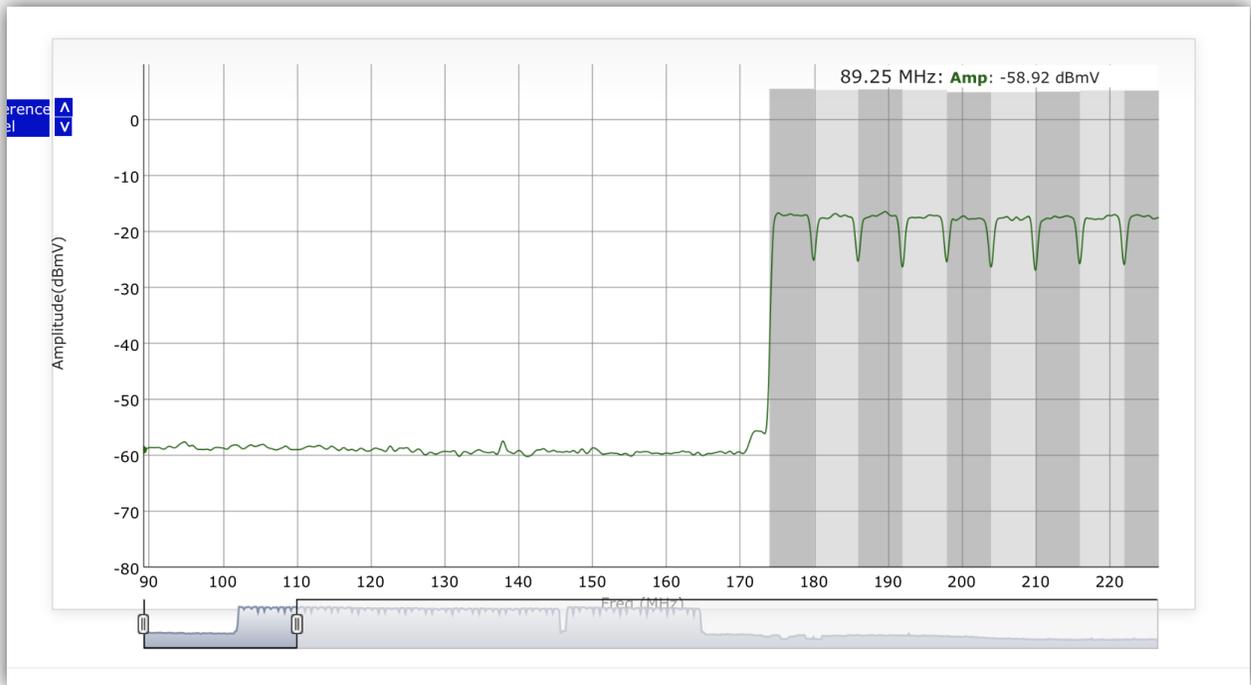
Figure 39: Subscriber 12 After replacing Drop and Bad Connectors. Note that the FM ingress is gone at 94 MHz

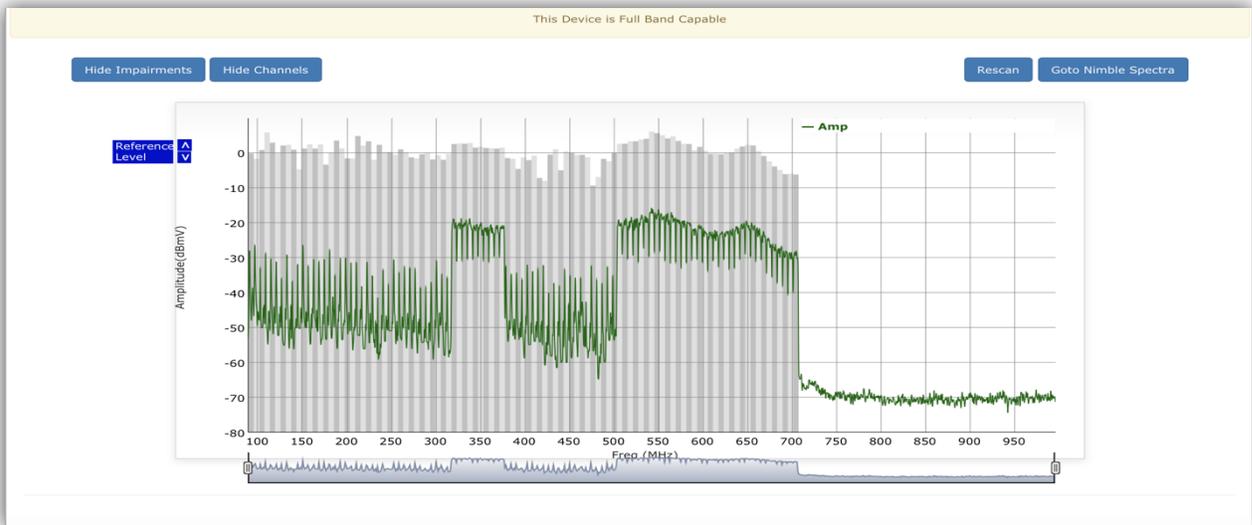
Figure 40: Subscriber 13 Before Repairs. Note the channel suck outs in the 400 MHz range

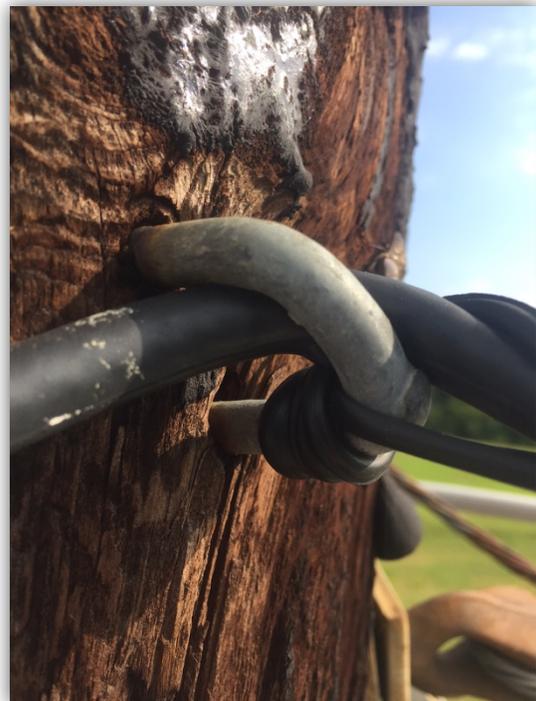
Figure 41: Drop cable looped around a j-hook connector causing the cable shielding to fail.

Replaced complete drop (two sections). The drop was looped around a j-hook connector causing significant depressions on adjacent sides of the drop. Also added a data only trap. See Figure 41.

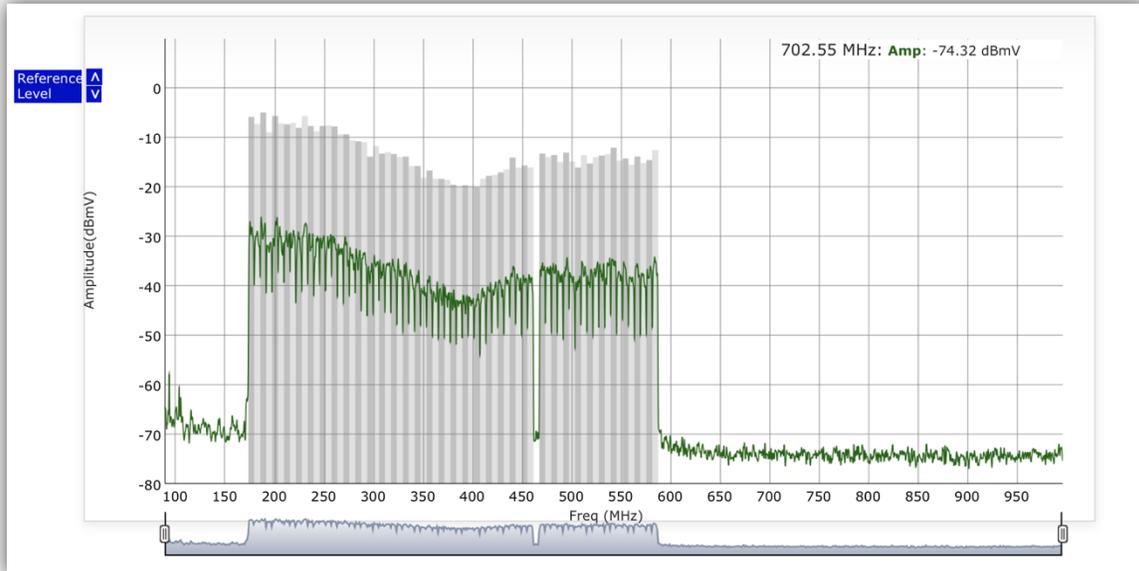
Figure 44: Subscriber 14 Levels before Repair. The levels drop to about -18 dBmV at 400 MHz

This subscriber was dealing with upstream noise issues, FM Ingress in the downstream, and a bad in-channel frequency response. The downstream level was very low at -18 dBmV. (See Figure 44). After troubleshooting with the M3 and QAM Compass, the drop was found to have multiple leaks. After speaking with the homeowner, it was revealed that the drop was buried shallow, just under the grass. The grass has been aerated several times and suspected that the lawn aerator hit the cable line. The cable was also missing a earth ground / ground block.

After replacing the drop, the downstream level increased from -18 dBmV to +2 dBmV.

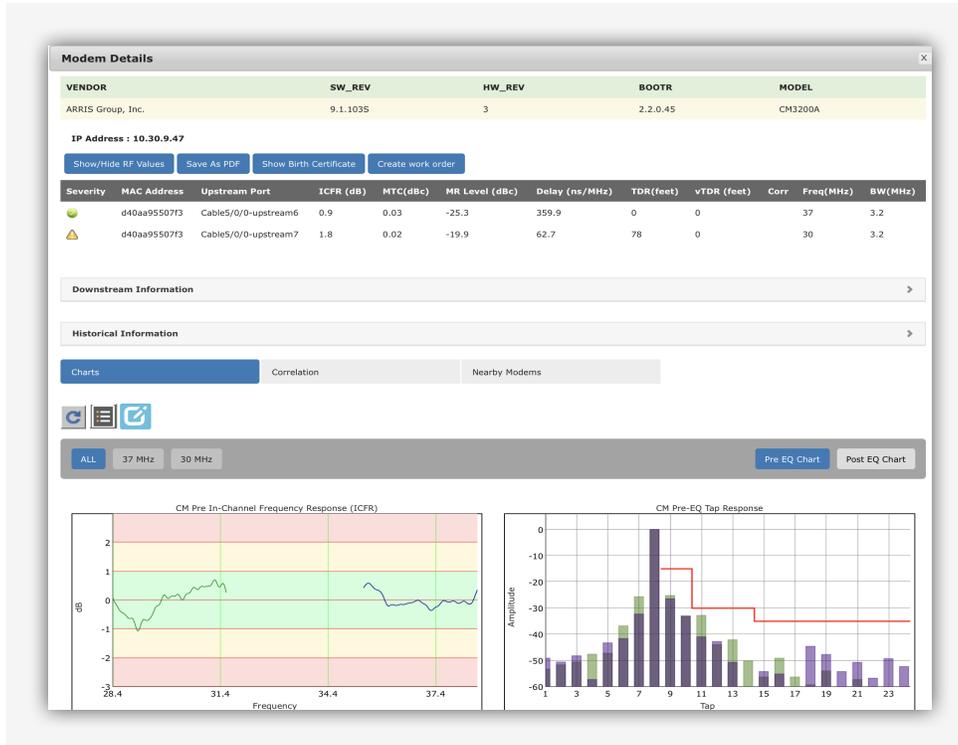
Figure 45: Subscriber 14 After repair. In Channel frequency response has improved

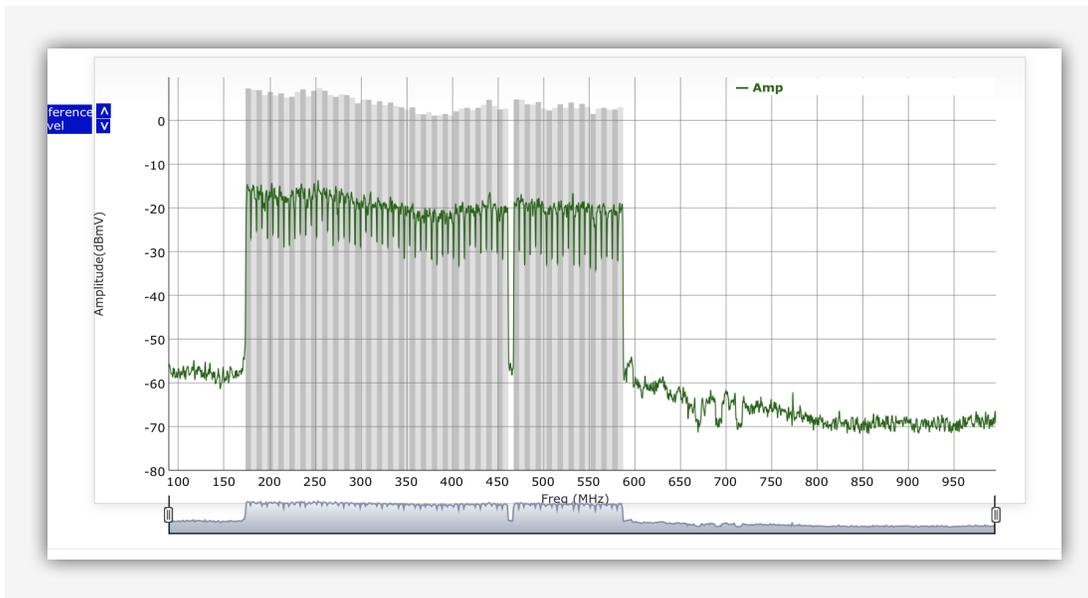
Figure 46: Subscriber 14 After repair. Channel Levels back to +2 dBmV

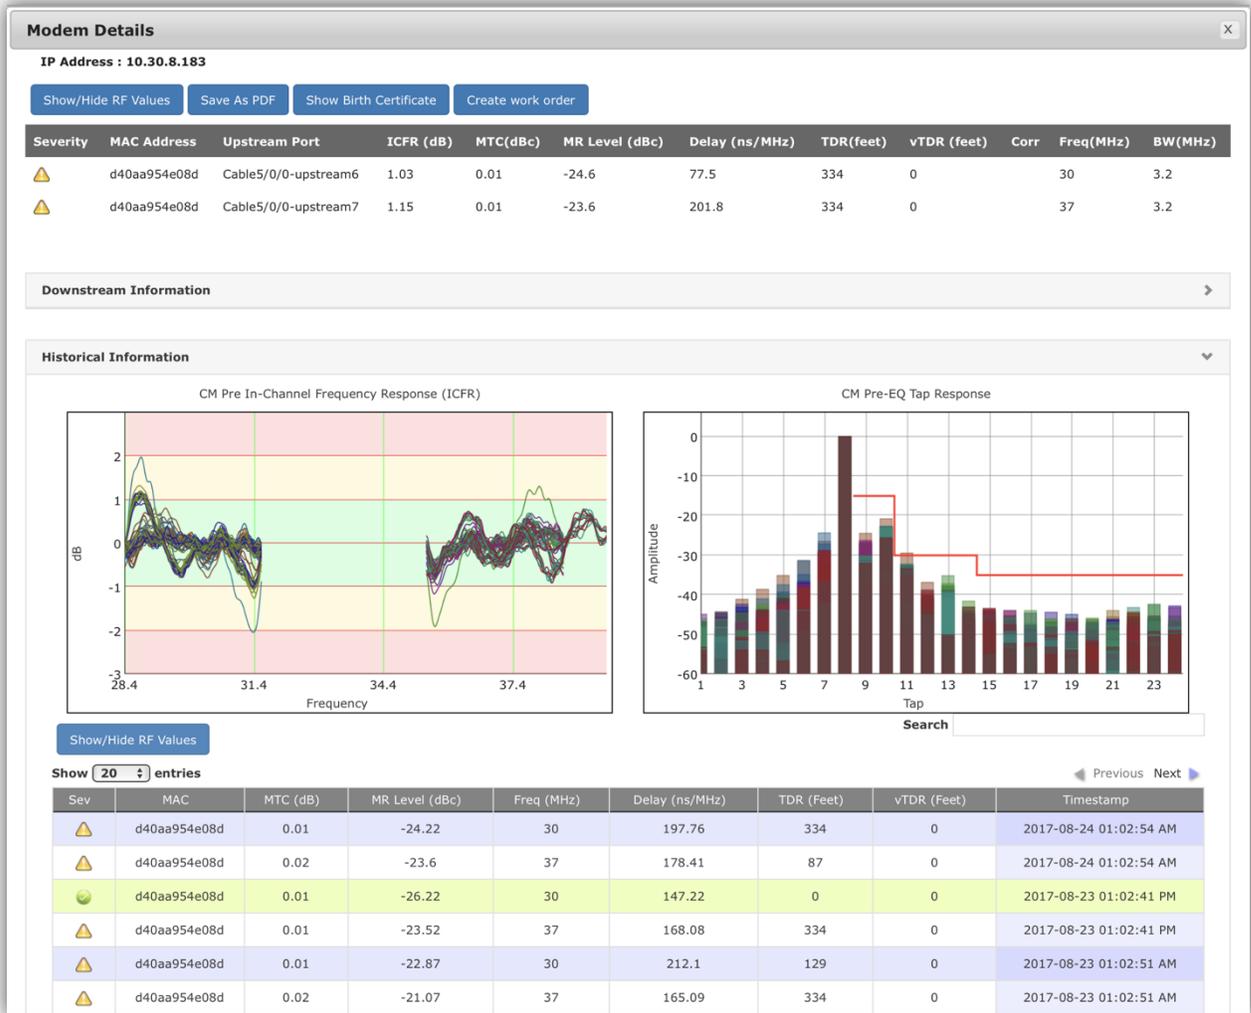
Figure 47: Subscriber 15 Before repair

Subscriber 15 exhibited problems of intermittent upstream, FM ingress and Tilt in the downstream.

Problems found in crimp on connectors, a defective multiport splitter and a house amp that was not needed. Repaired all problems found which dramatically improved the return path channel response and returned the modem to a green status.
