NIMBLE THIS PROACTIVE NETWORK MAINTENANCE AND COMSONICS SIGNAL LEAKAGE TOOLS

*A Valuable System for Isolating RF Impairments that Radically Aid Drop and
In-Home / Near Home Issue Resolution*

NIMBLE THIS LLC AND COMSONICS INC.

August 18, 2017

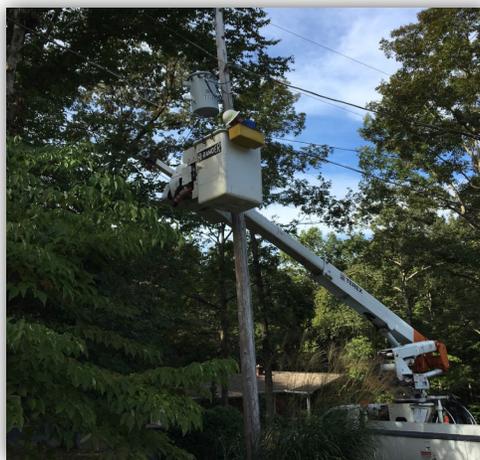
Figure 3: Technician installing M3 Signal Injector

At subscriber 1's house we knew there is a micro-reflection based on the Nimble This PNM data. There are two approaches to fix the problem. The first and most common approach is to replace connectors, splitters and maybe even the drop until the modem turns from red to green. The second and quicker option is to disconnect the drop at the mainline tap, connect ComSonics' M3, which injects high level RF signals and then look for RF leaks along the drop and inside the home with the ComSonics QAM Compass. Figure 3 shows the technician installing the M3 at the drop.

Once the M3 and QAM Compass were powered on, the technician immediately found a high level leak at the mainline tap while he was still in the bucket. There he found a splice had been

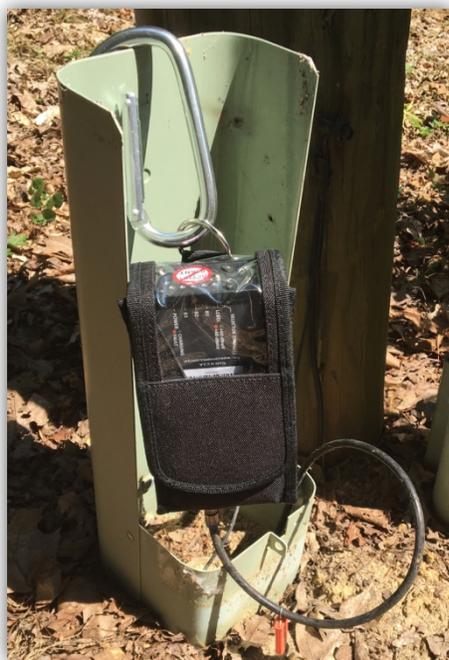
Figure 8: ComSonics' M3 Connected to Subscriber Buried Drop Cable

In all field tests performed, Nimble This PNM and ComSonics' M3 signal generator were used. As shown in Figure 8 the drop is buried and ComSonics' M3 connected.

Once connected and powered up, the M3 transmits high signal levels into the subscriber's drop and home (not the HFC plant!). Almost immediately the leakage detector (ComSonics' QAM Compass) started detecting a M3 leak. The technician started walking around the subscriber's house where low level signals appeared present nearly everywhere. Over a period of five minutes the technician found the highest signal level to be near the buried drop cable. This indicates that the RF leak was coupled to the shield of the drop cable buried underground.

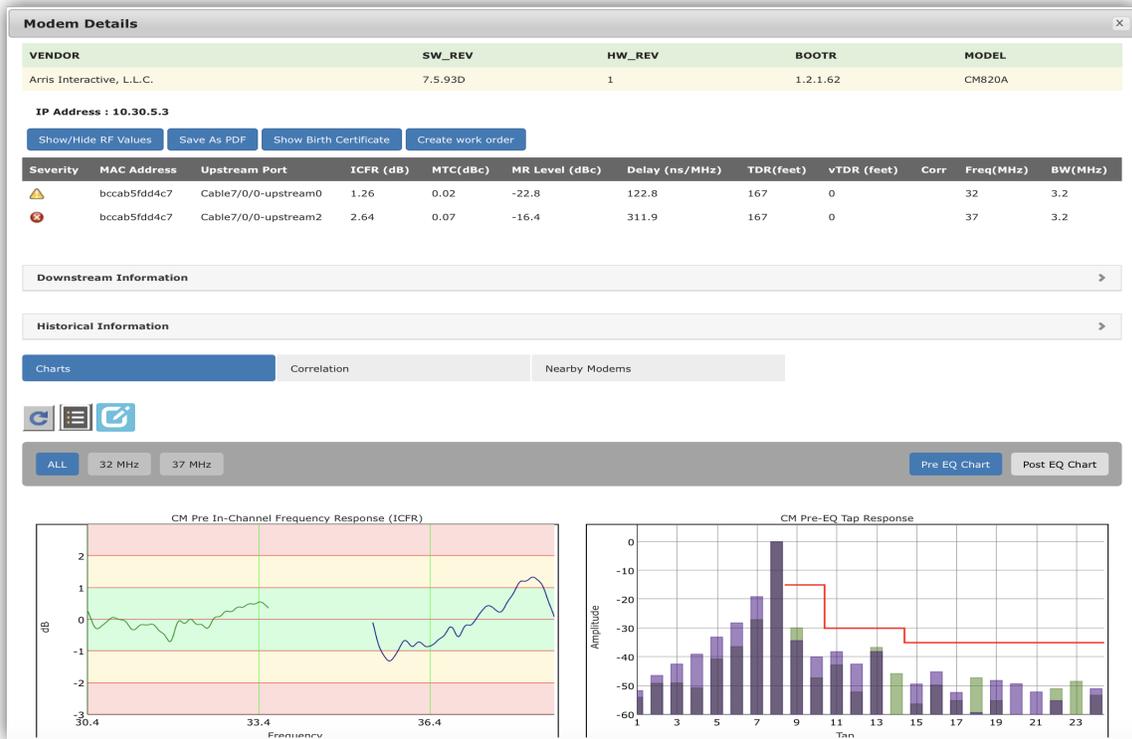
Figure 25: Subscriber 6 Modem After Repair

Impairment Found: Intermittent issue due to faulty TVC Arrestor Ground Block. The faulty ground block shown in Figure 24 was only detected because it was leaking significant amounts of ComSonic’s M3 RF energy. Faulty ground blocks are not common, but it is assumed this “surge arresting” type ground block had been damaged by a surge.

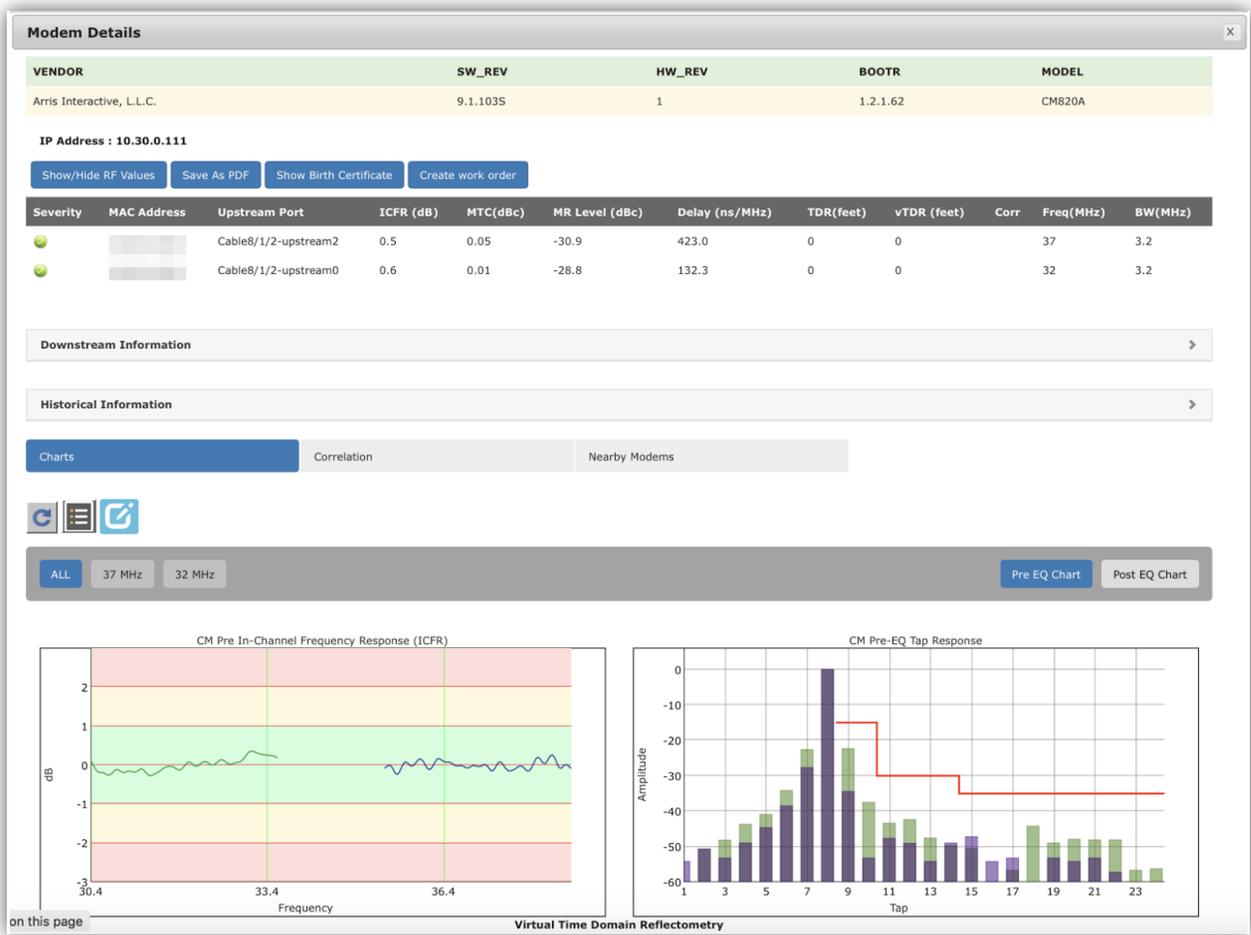
Figure 27: Subscriber 7 Modem After Repair

Impairment Found: Multiple leaks found inside the house due to crimp-on style F-connectors and an unnecessary house-amp in front of the modem. Upon replacing all older style connectors with quality connectors, no leaks were observed and the modem response in Figure 27 resulted.

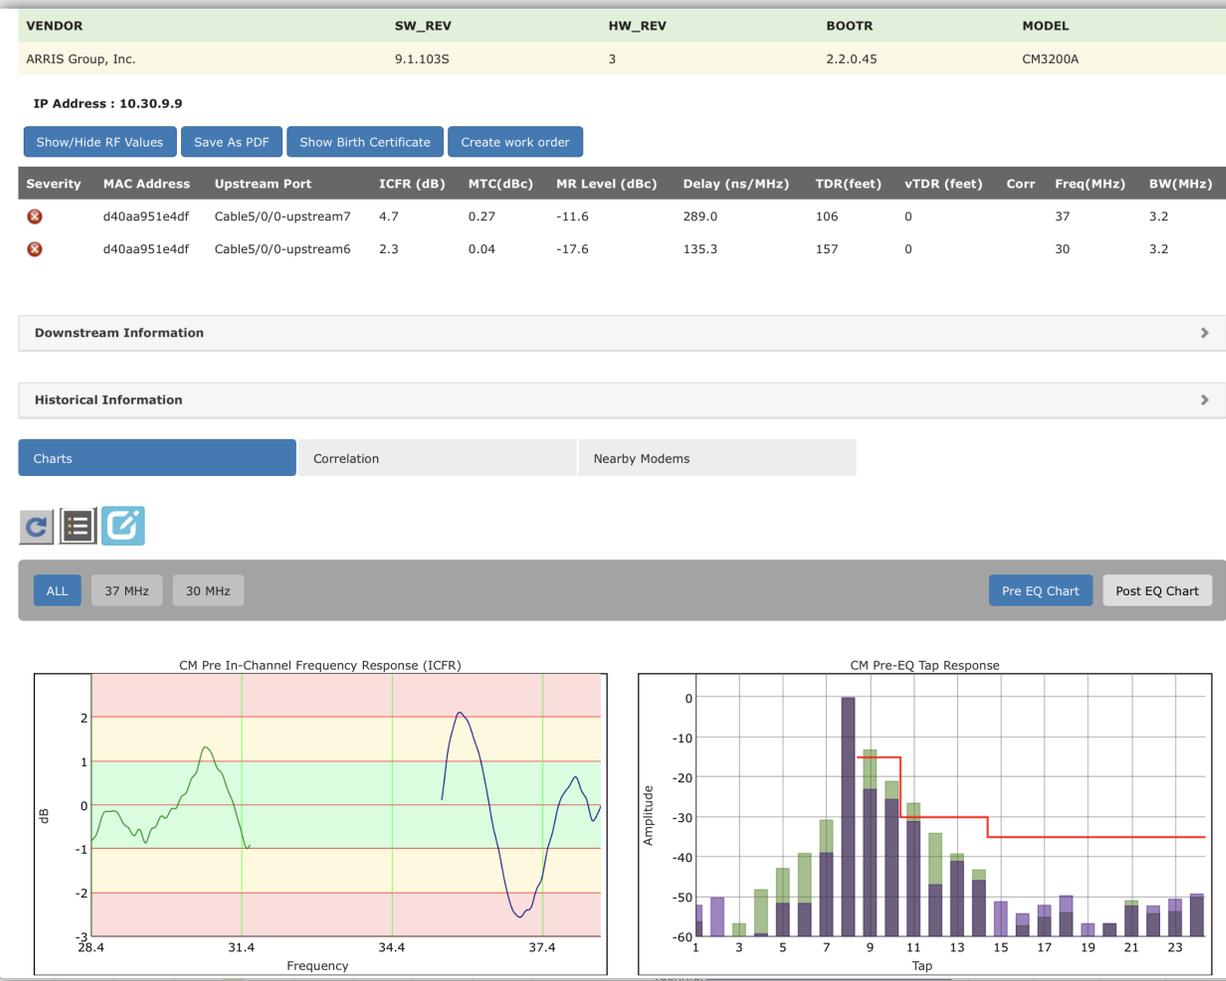
Figure 37: Subscriber 11 Modem After replacing drop

Subscriber 11: Replaced the drop which was damaged or had an existing bad splice (tracked with M3/Compass). Found a unterminated cable outlet inside the house with a very large leakage. The rest of the inside was quiet. After repairs, the downstream improved significantly, but there was still an issue with the modem. The problem was most likely due to a problem on the network side.

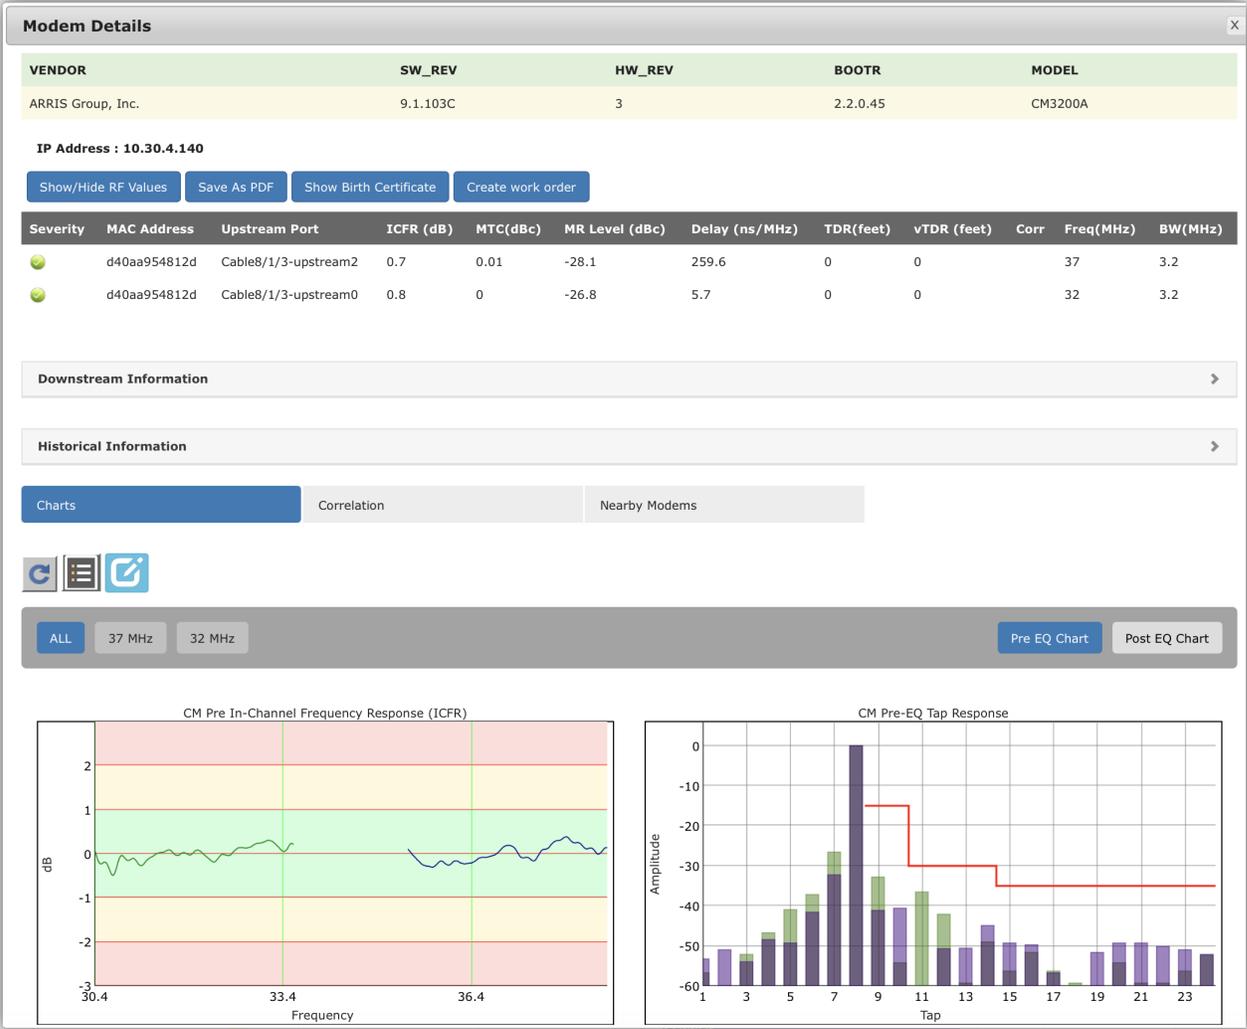
Figure 42: Subscriber 13 After Repairs

Replaced complete drop (two sections). The drop was looped around a j-hook connector causing significant depressions on adjacent sides of the drop. Also added a data only trap. See Figure 41.

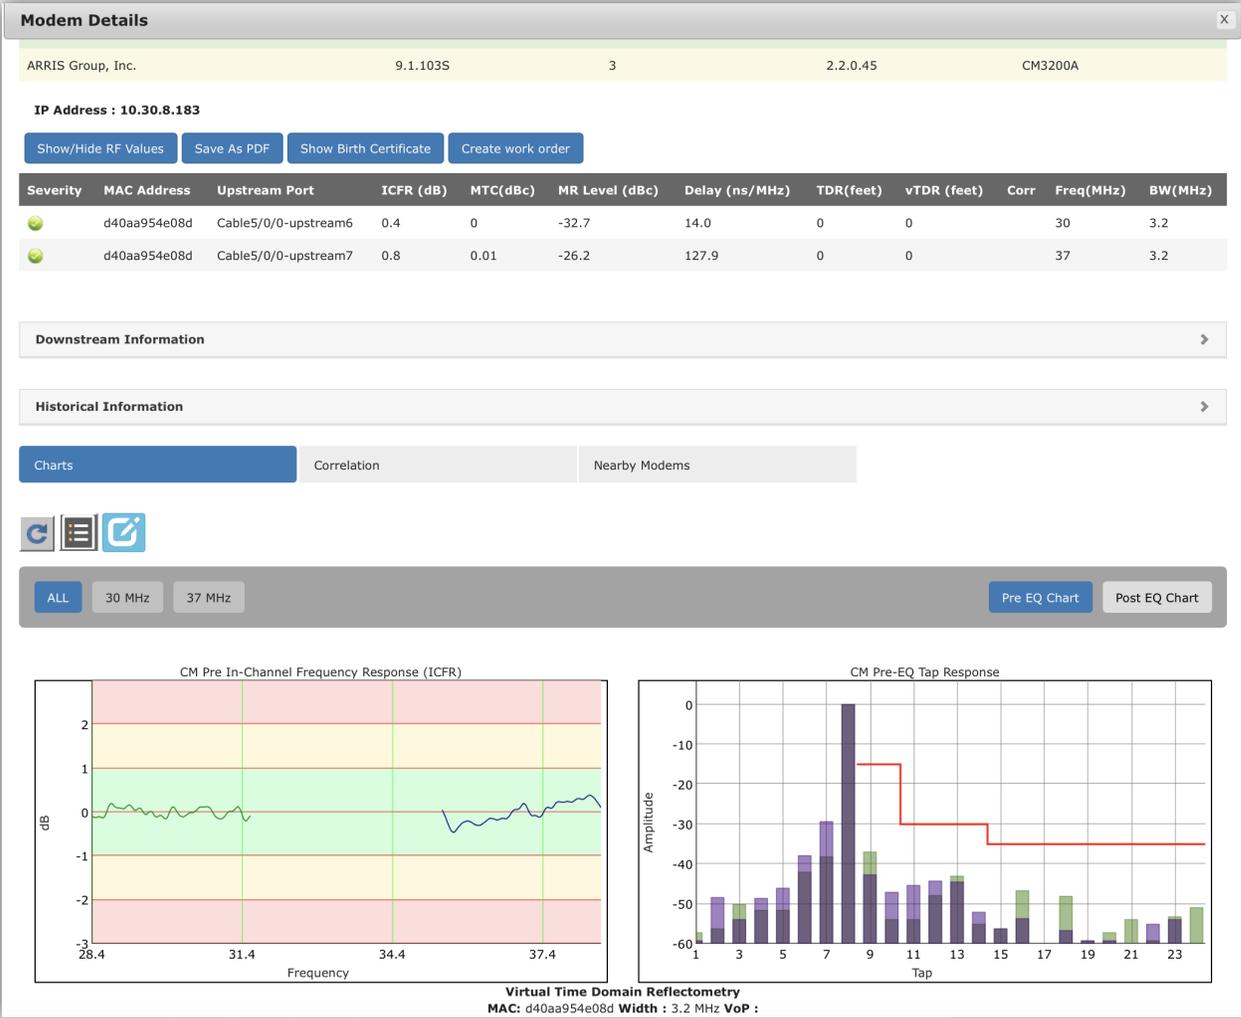
Figure 48: Subscriber 15 After Repair

Subscriber 15 exhibited problems of intermittent upstream, FM ingress and Tilt in the downstream.

Problems found in crimp on connectors, a defective multiport splitter and a house amp that was not needed. Repaired all problems found which dramatically improved the return path channel response and returned the modem to a green status.
